Inspection Report

South Auction Realty

Property Address:
1341 Old Wadley Road
Swainboro Ga

Date: 4/13/2022	Time:	Report ID:
Property: 1341 Old Wadley Road Swainboro Ga	Customer: South Auction Realty	Real Estate Professional:

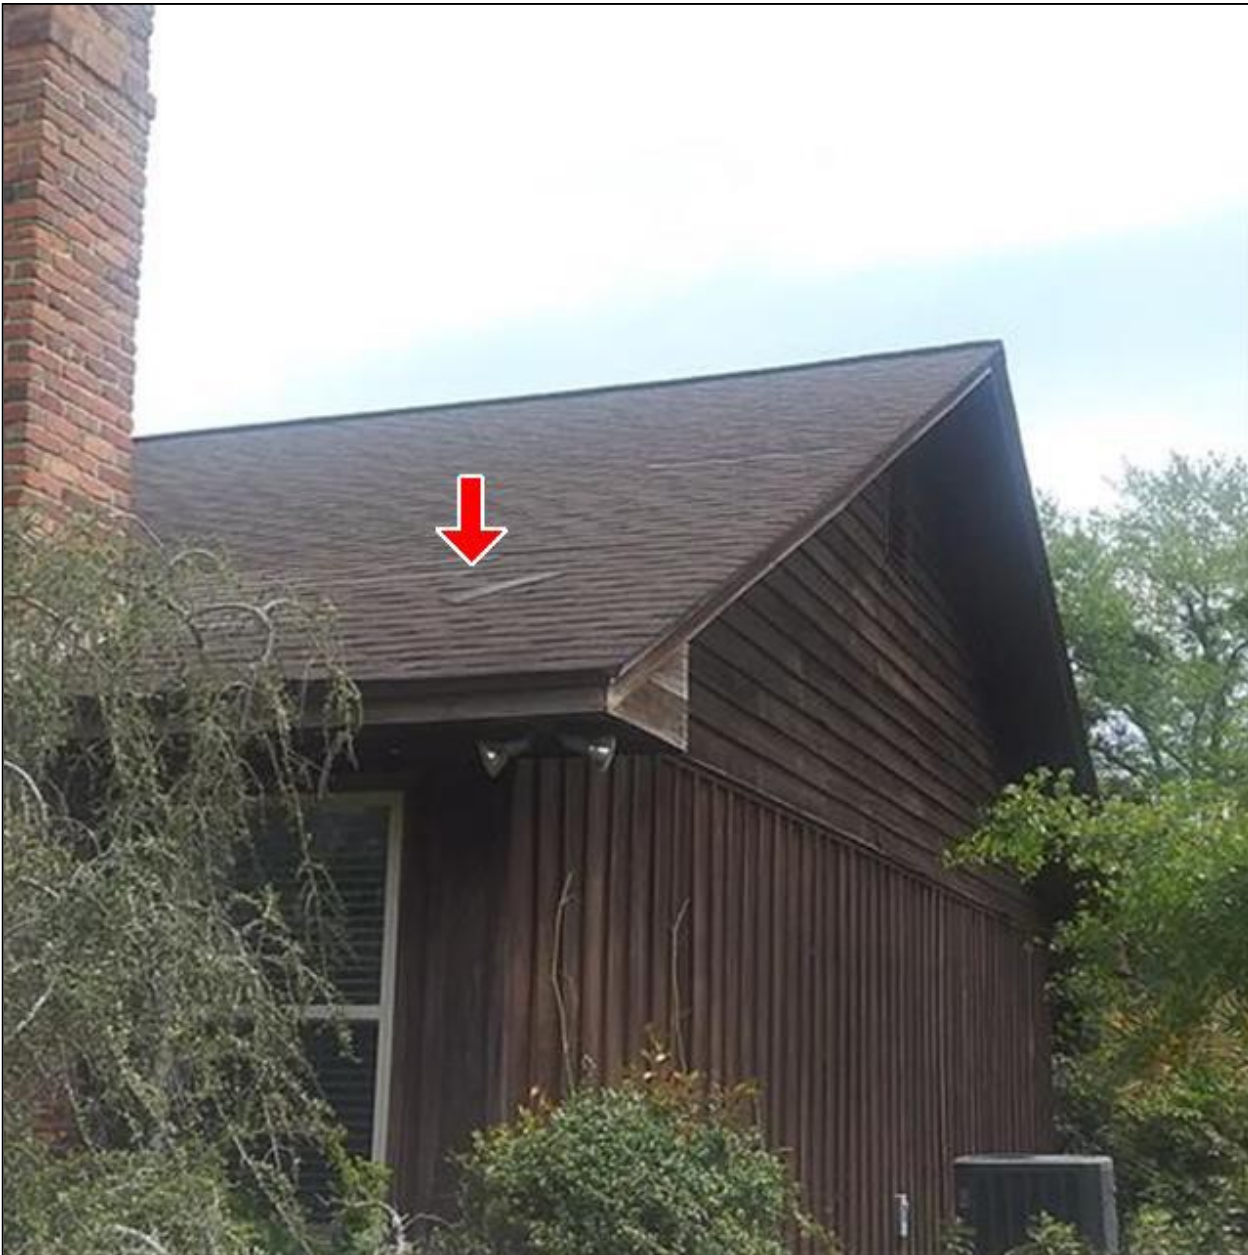
1.0 (1) The roofing has a shingle loose to the right side of home.

1.0 Item 1(Picture) The roofing has a shingle loose to the right side of home.

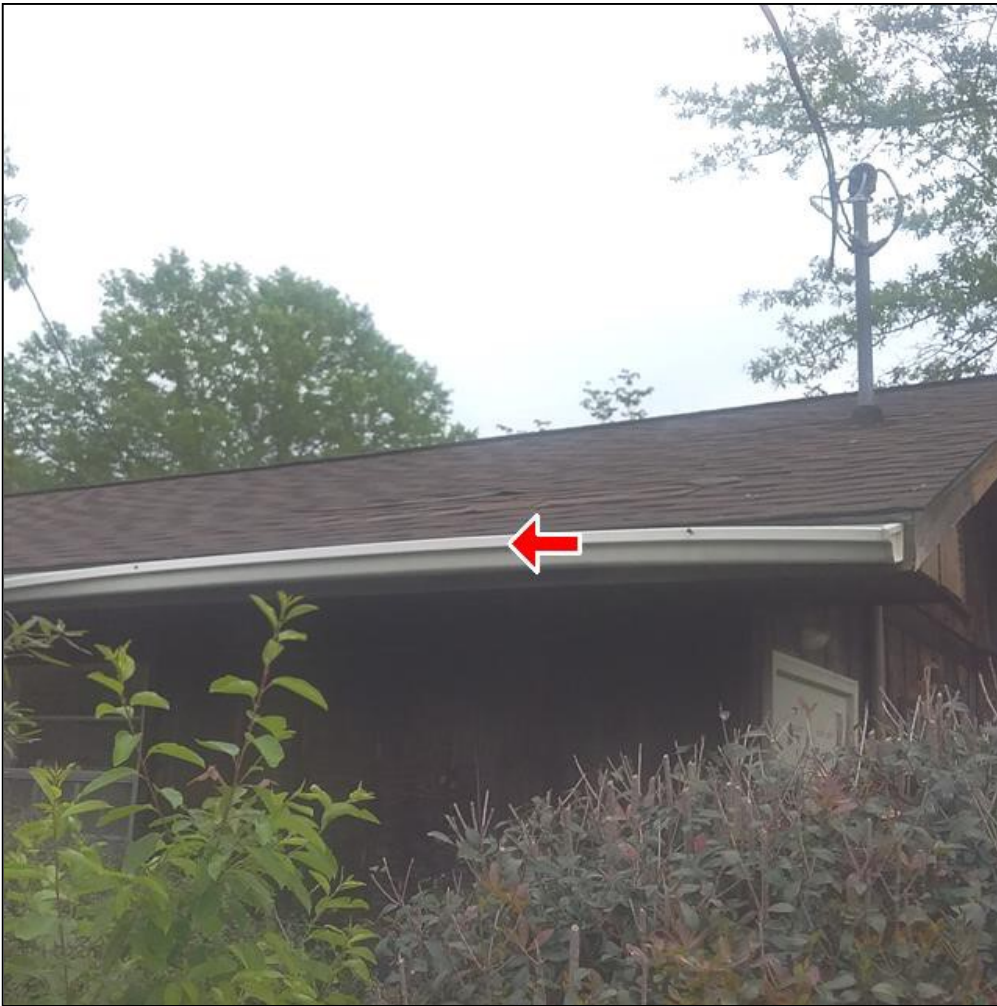
1.0 (2) Cottage roof gutter needs to be straightened or replaced.

1.0 Item 2(Picture) Cottage roof gutter needs to be straightened or replaced.

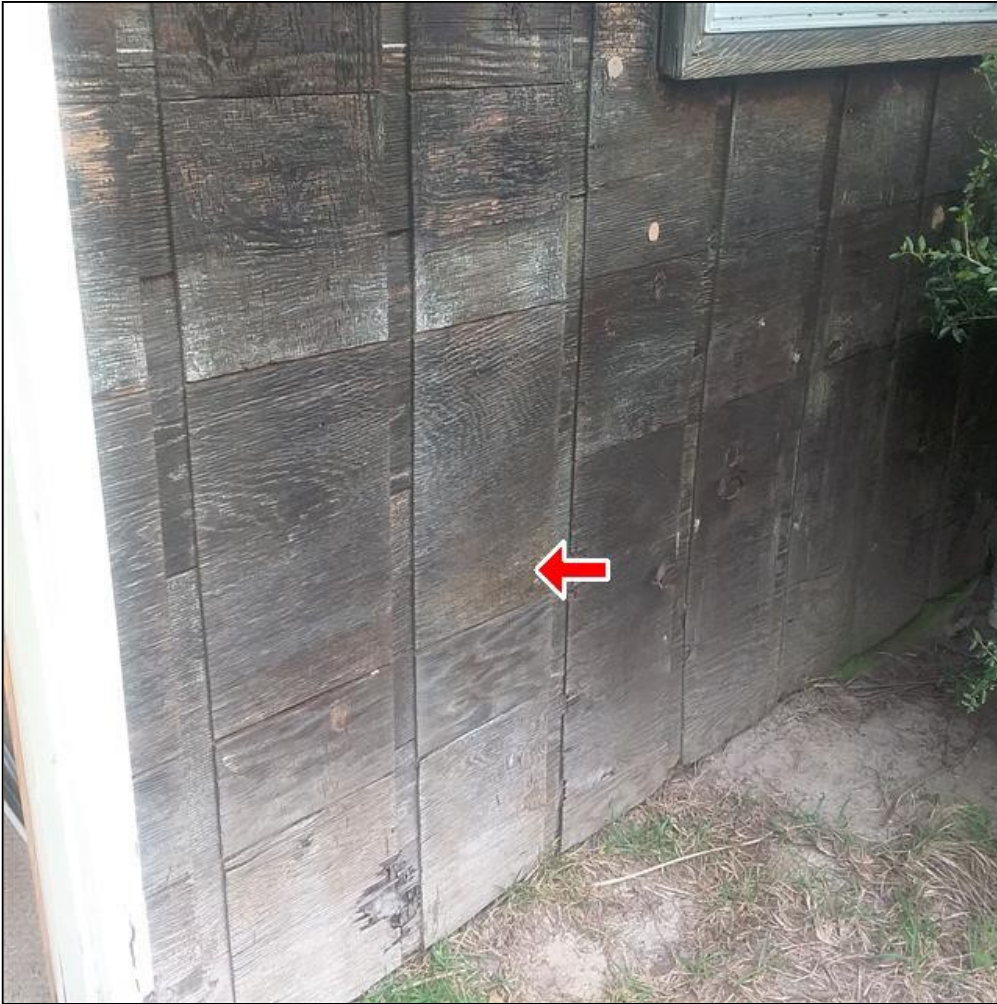
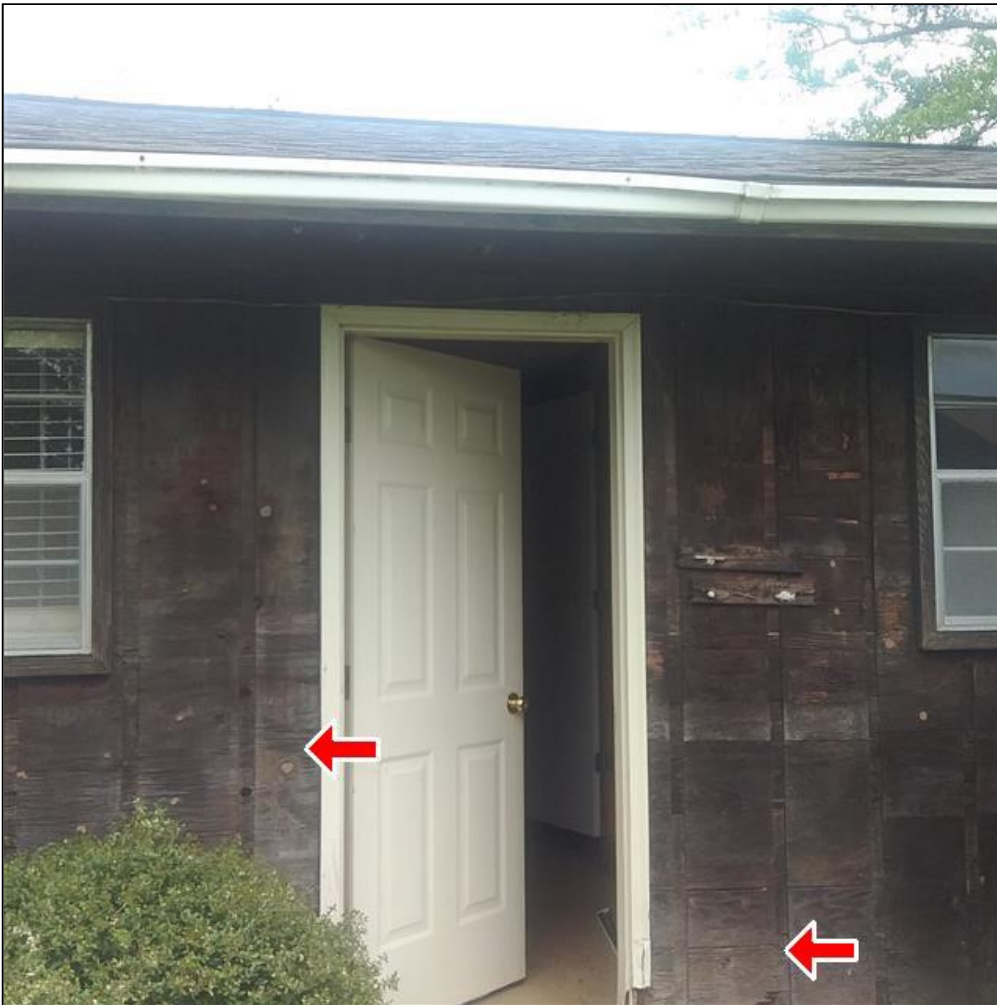
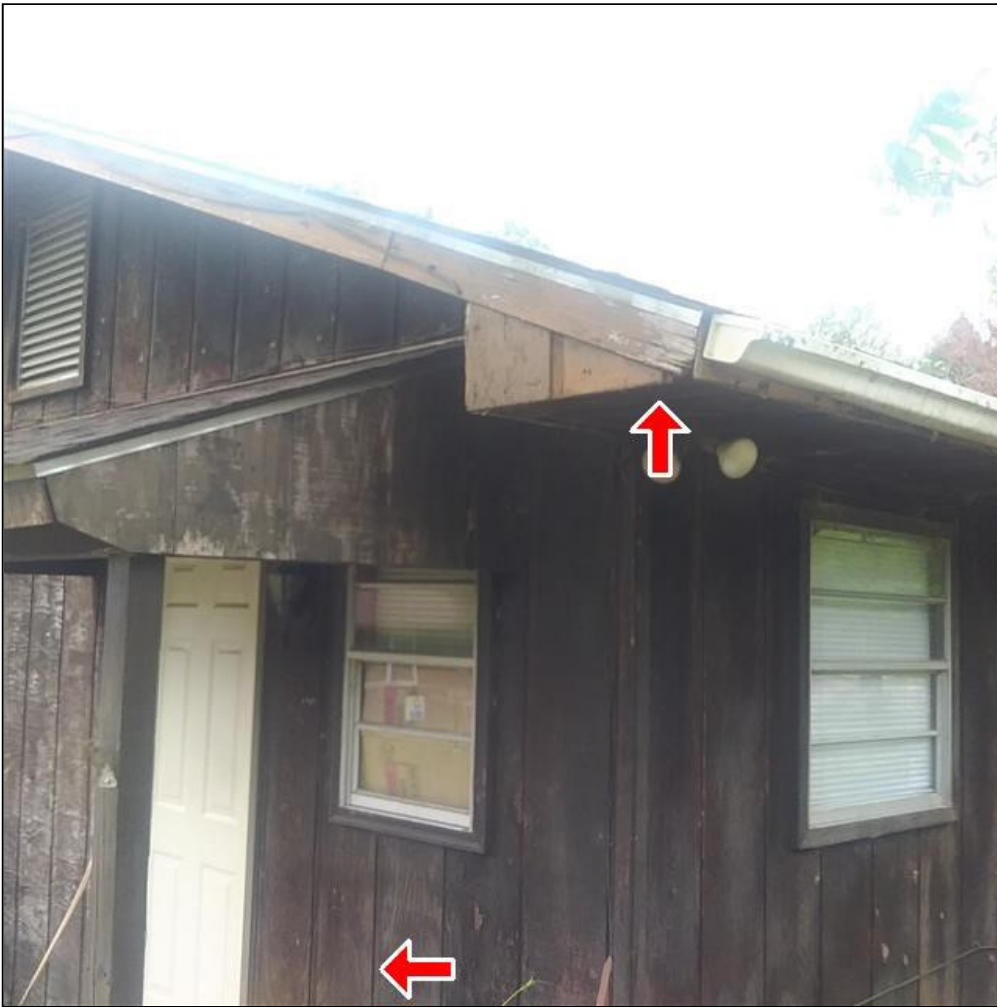
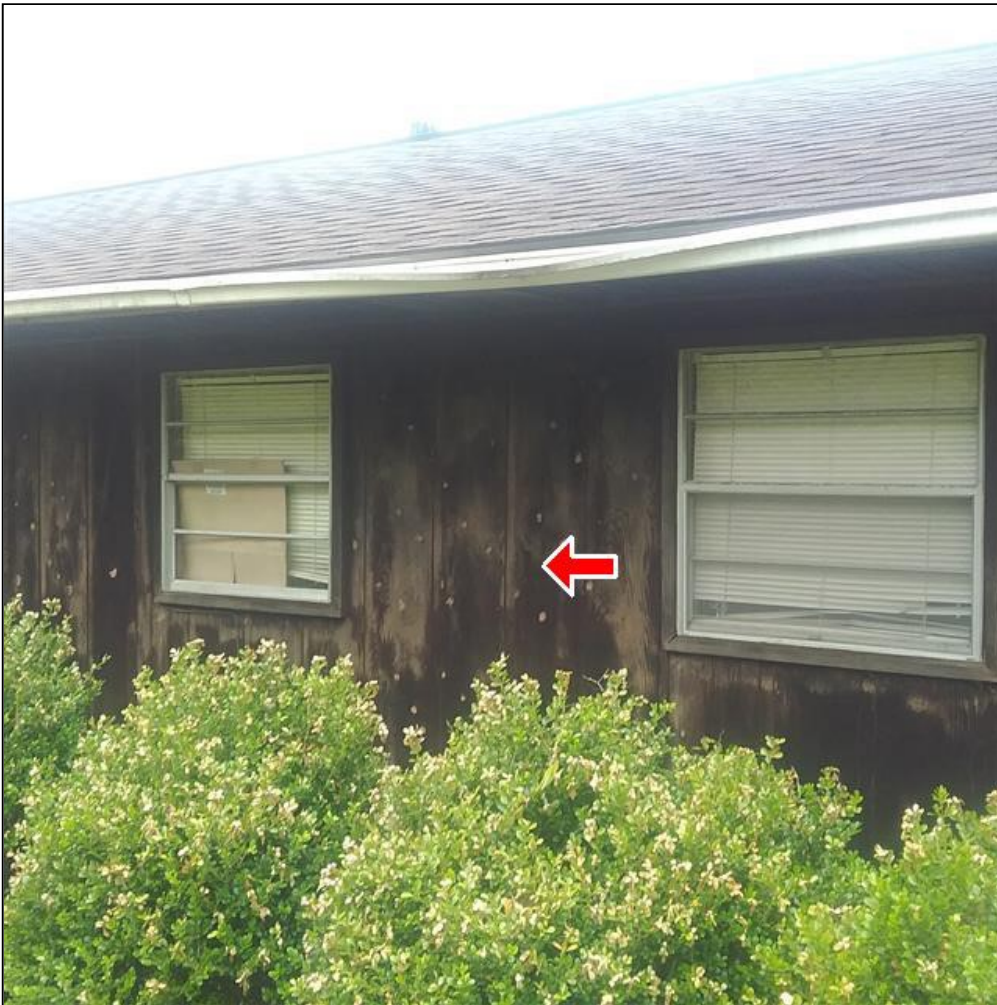
2.0 Exterior wall siding, trim, and fascia on Cottage needs to be painted or stained to prevent wood rot.

2.0 Item 1(Picture) Exterior wall siding, trim, and fascia on Cottage needs to be painted or stained to prevent wood rot.

2.0 Item 2(Picture) Exterior wall siding, trim, and fascia on Cottage needs to be painted or stained to prevent wood rot.

2.0 Item 3(Picture) Exterior wall siding, trim, and fascia on Cottage needs to be painted or stained to prevent wood rot.

2.0 Item 4(Picture) Exterior wall siding, trim, and fascia on Cottage needs to be painted or stained to prevent wood rot.

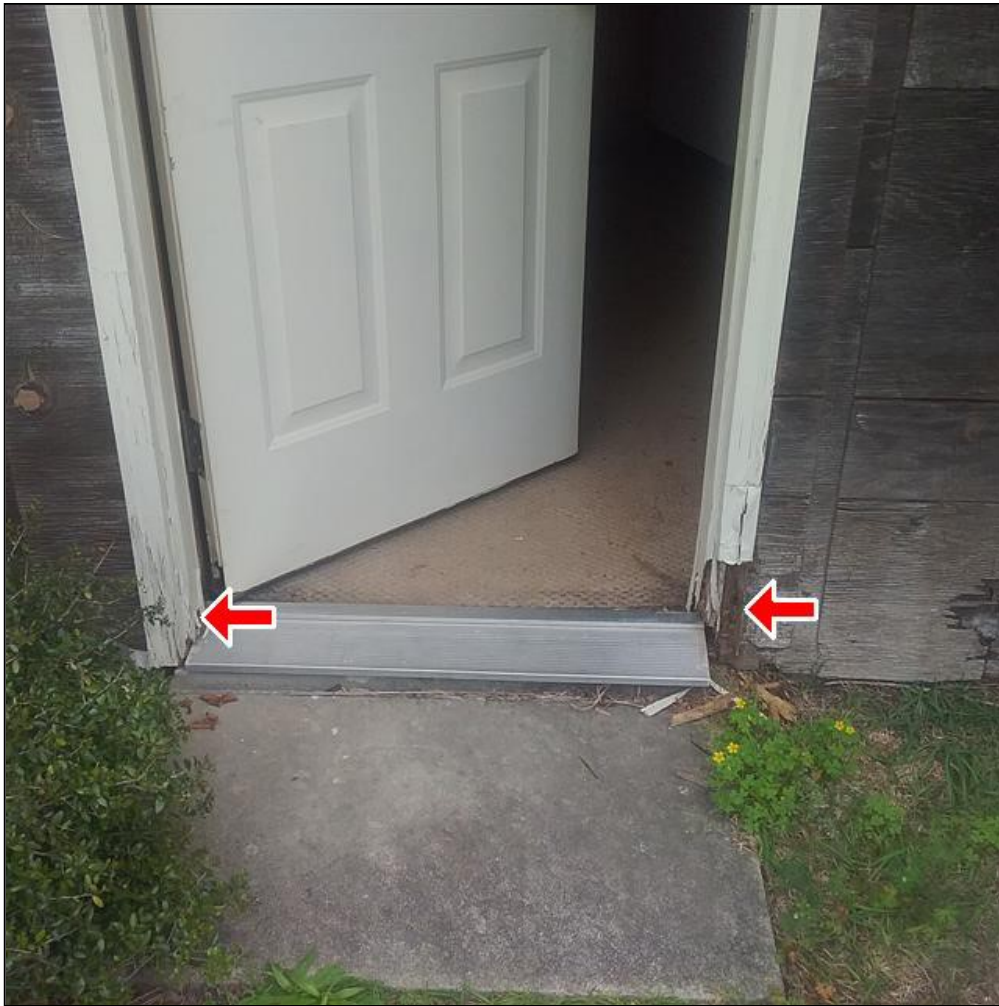
2.1 The wood door trim has water damage needing to be repaired, or replaced.

2.1 Item 1(Picture) The wood door trim has water damage needing to be repaired, or replaced.

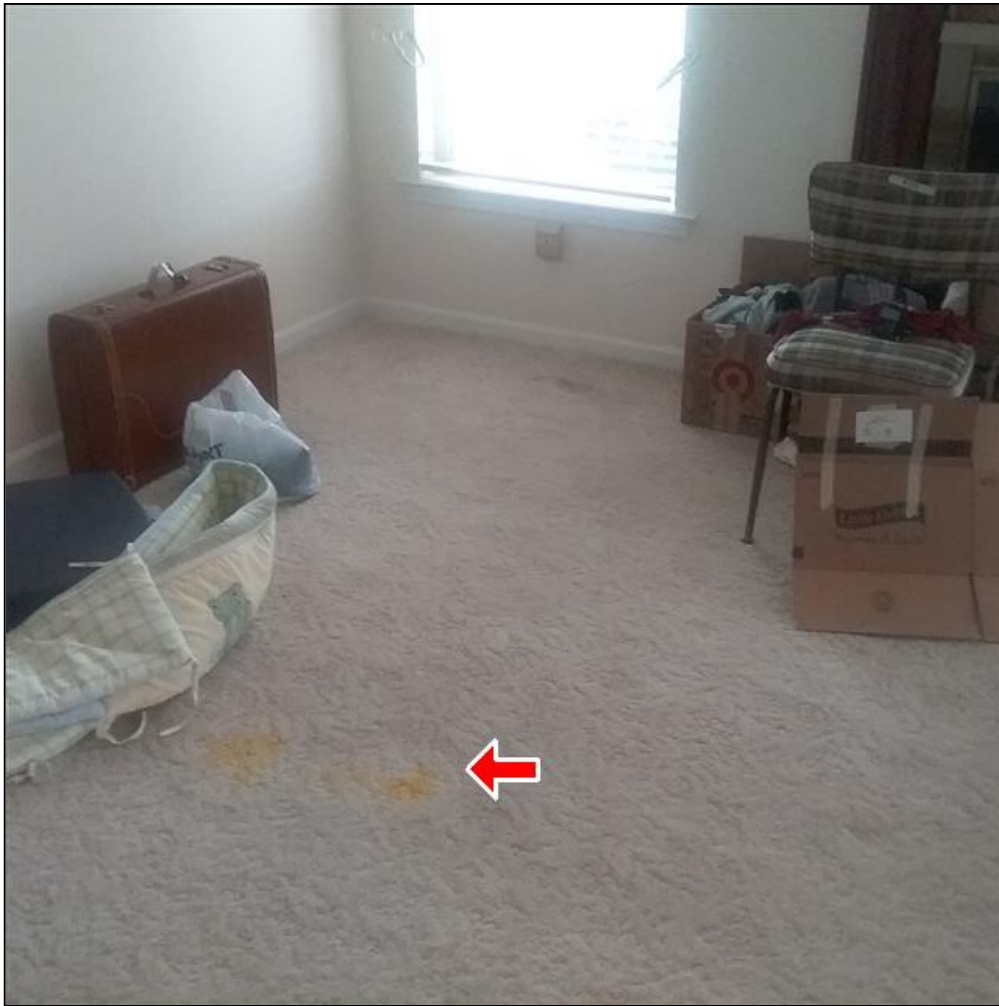
4.2 (1) Front right bedroom carpet needs to be replaced

4.2 Item 1(Picture) Front right bedroom carpet needs to be replaced

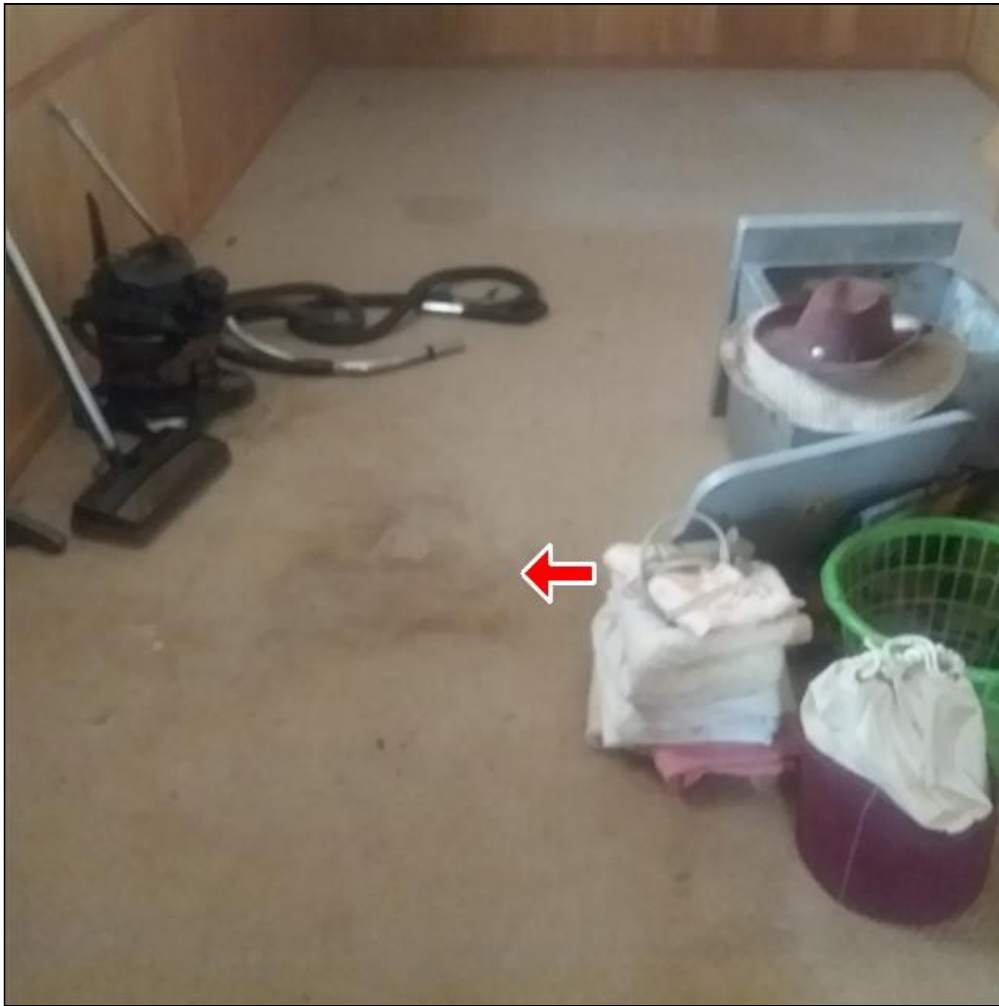
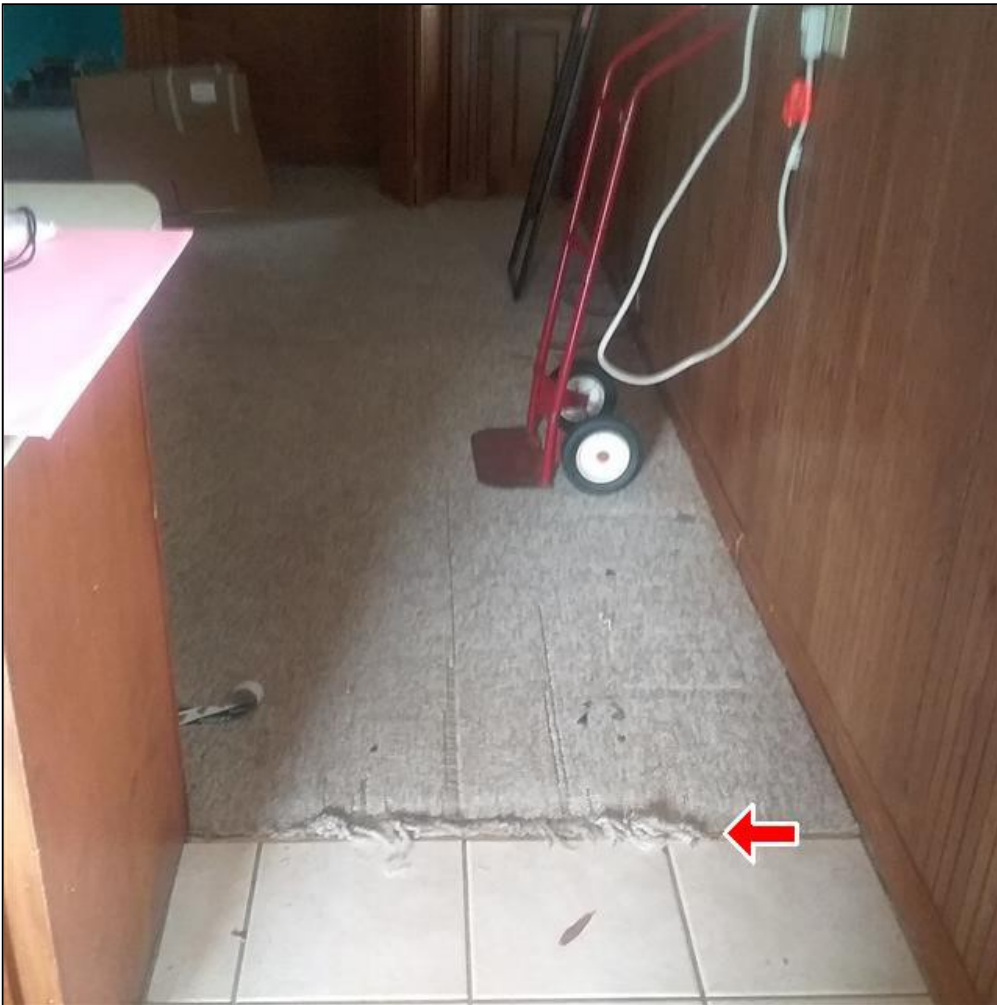
4.2 (2) The carpet in Cottage needs to be replaced.

4.2 Item 2(Picture) The carpet in Cottage needs to be replaced.

4.2 Item 3(Picture) The carpet in Cottage needs to be replaced.

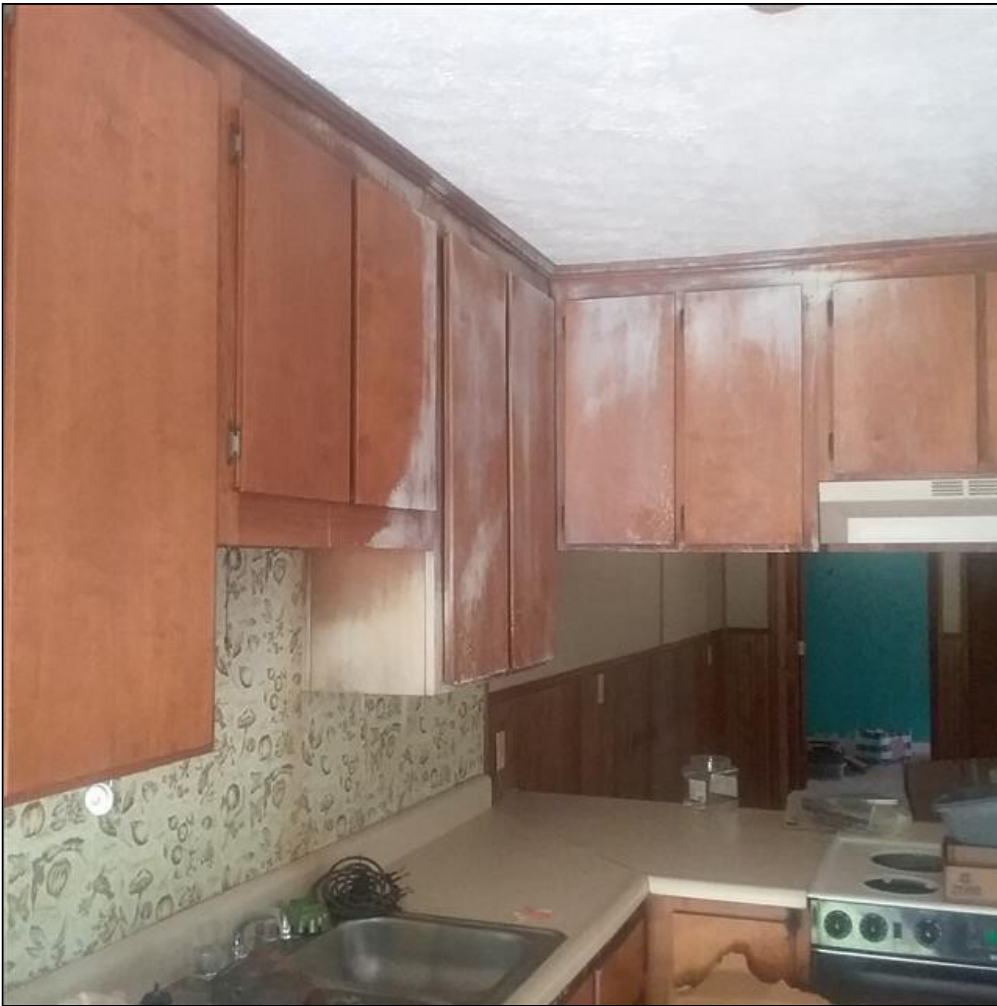
4.4 Cottage cabinets need to be cleaned, and re-stained.

**4.4 Item 1(Picture) Cottage cabinets need to be cleaned, and re-stained.**

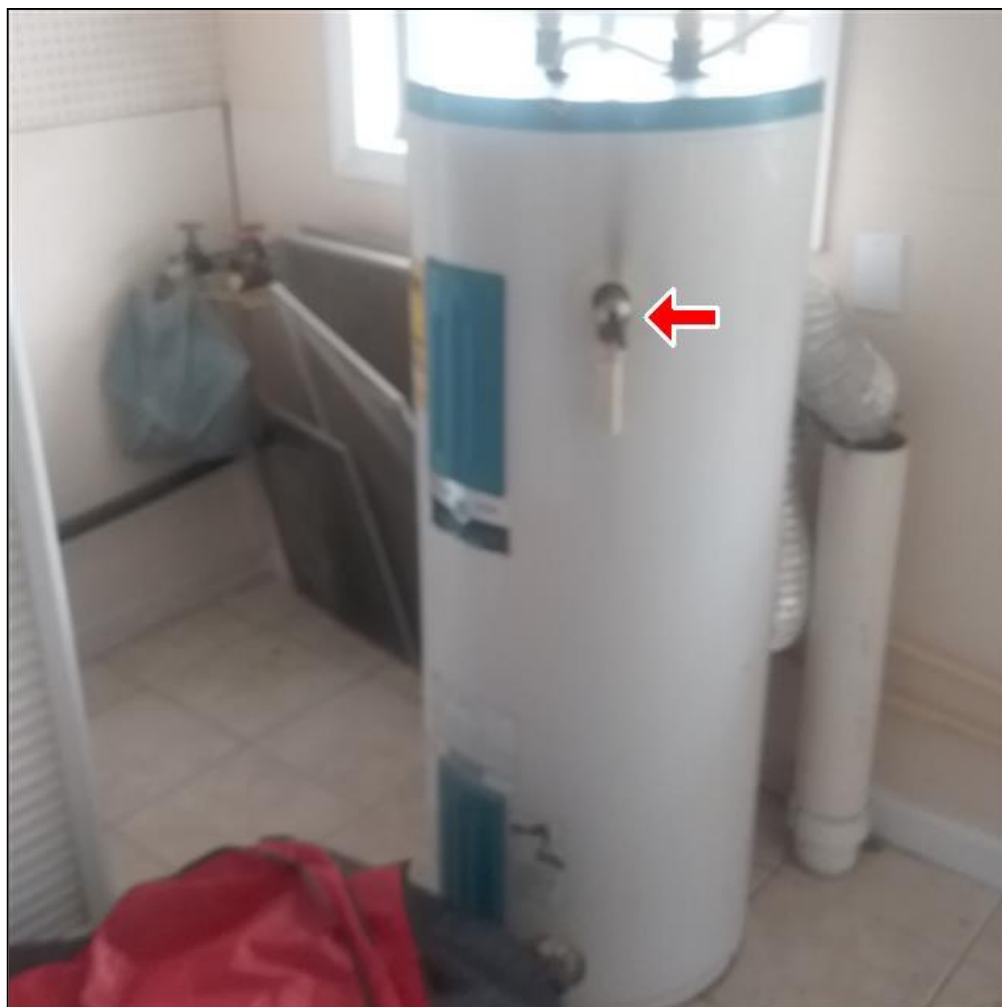
6.2 Cottage water heater needs to have pressure / temperature relief valve piped to exterior.

6.2 Item 1(Picture) Cottage water heater needs to have pressure / temperature relief valve piped to exterior.

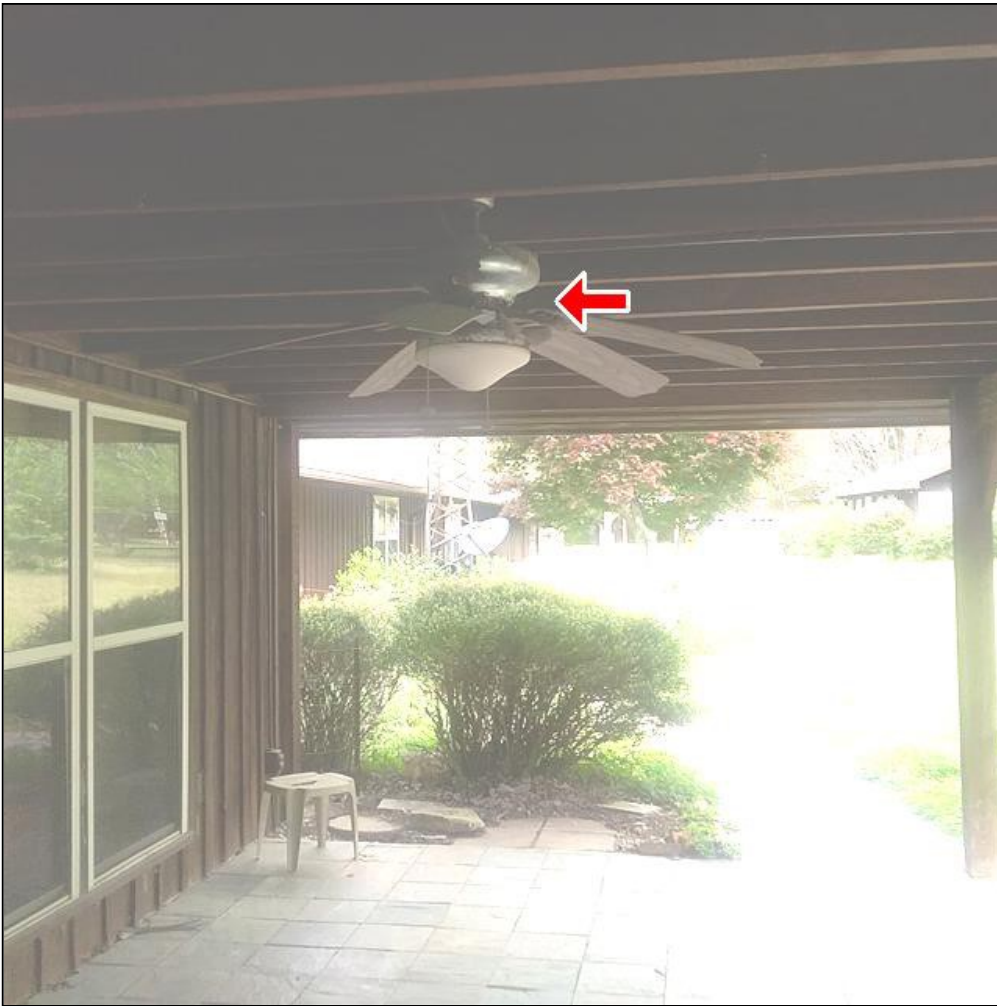
7.3 (1) The ceiling fan on the back needs to be replaced, as it has paint peeling off motor housing, and blades are drooping.

7.3 Item 1(Picture) The ceiling fan on the back needs to be replafed, as it has paint peeling off motor housing, and blades are drooping.

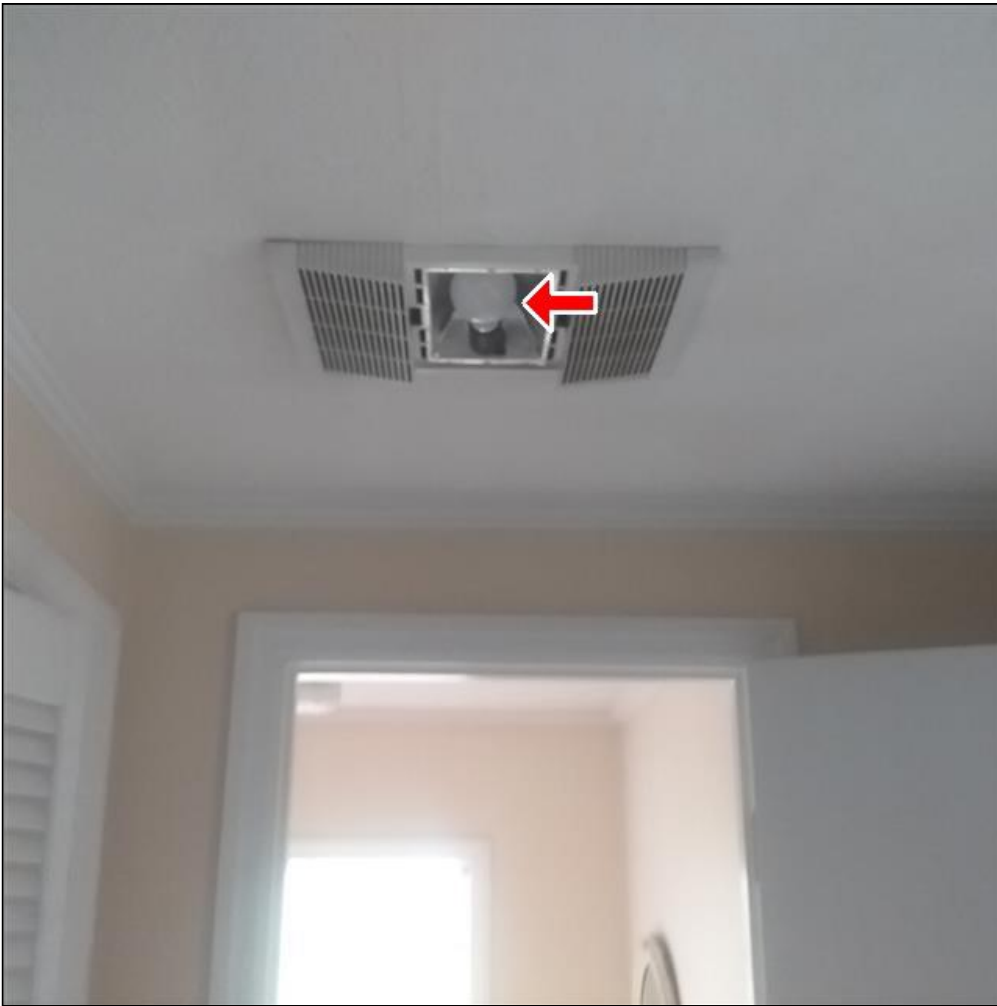
7.3 (2) Light needs cover in bathroom.

7.3 Item 3(Picture) Light needs cover in bathroom.

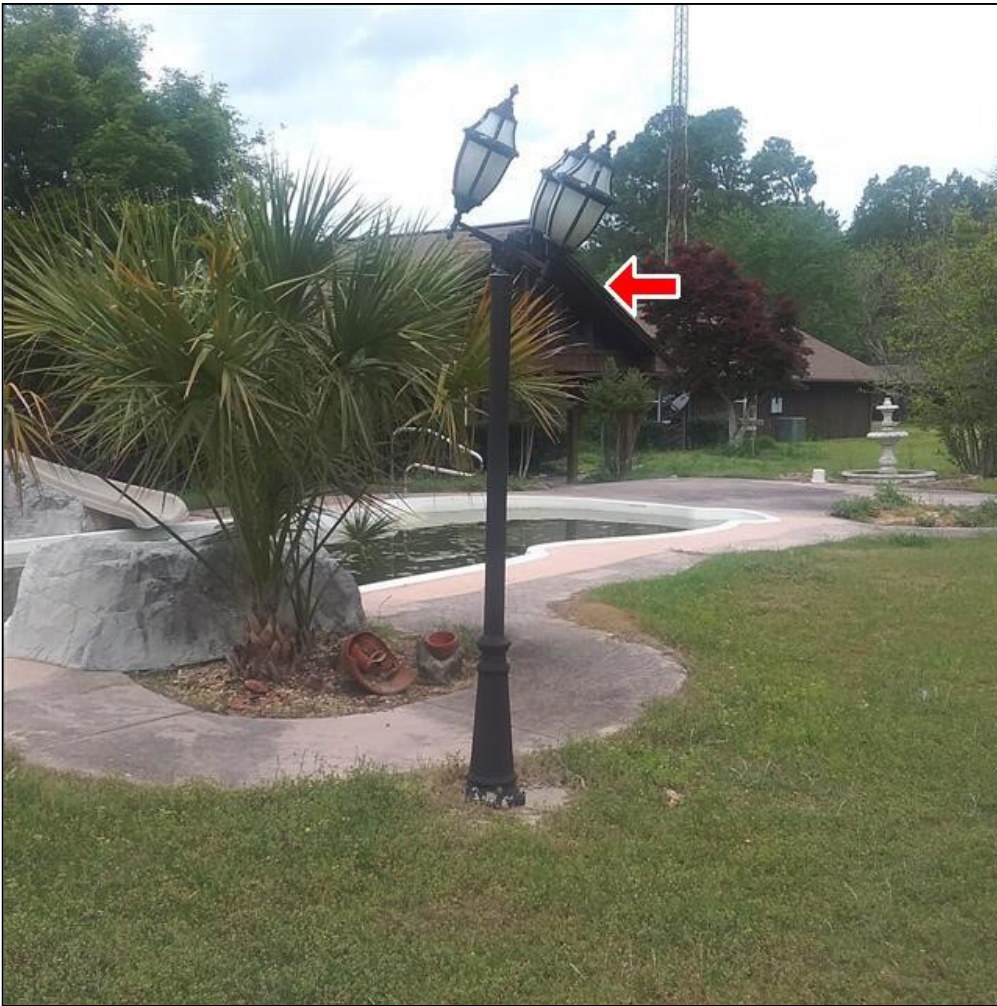
7.3 (3) The exterior post lamp needs repair.

7.3 Item 4(Picture) The exterior post lamp needs repair.

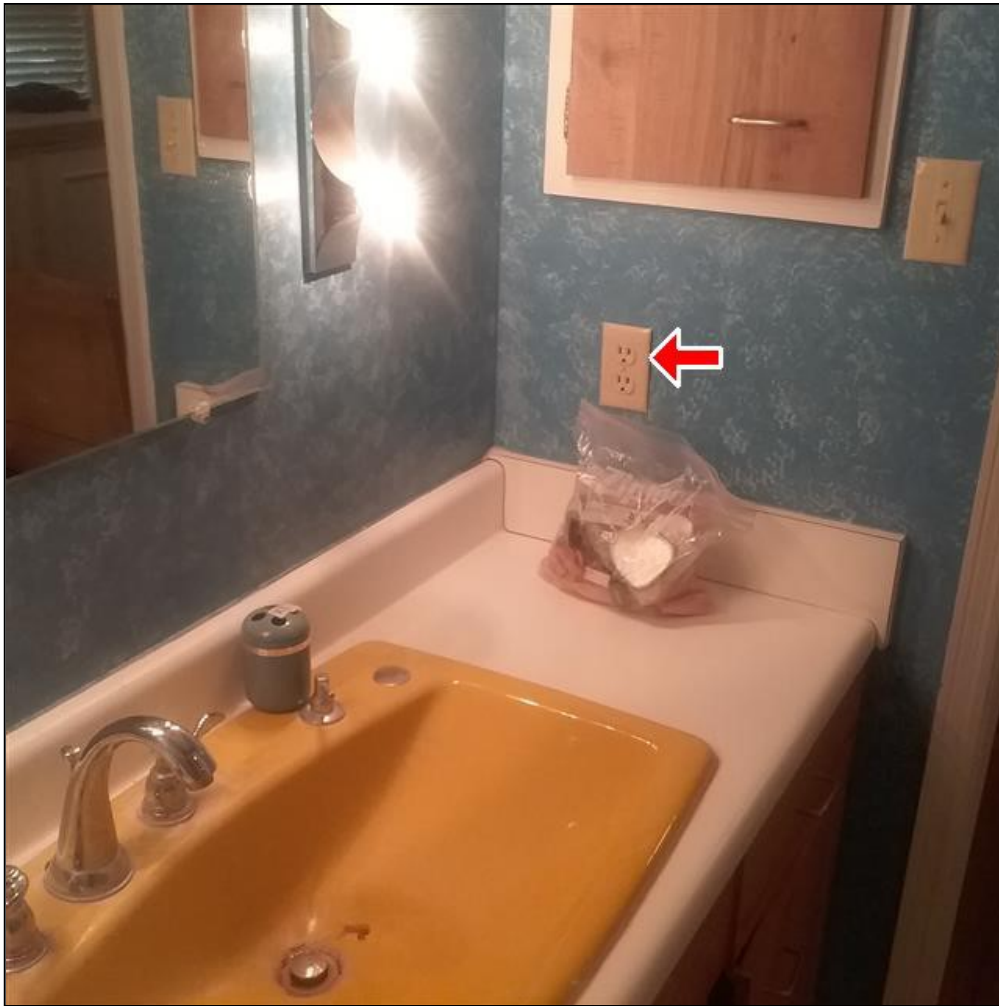
7.5 All electrical receptacles within 6 feet of water on interior, or any on exterior should be ground fault circuit protected.

7.5 Item 1(Picture) Receptacle needs to be changed to GFCI type receptacle.

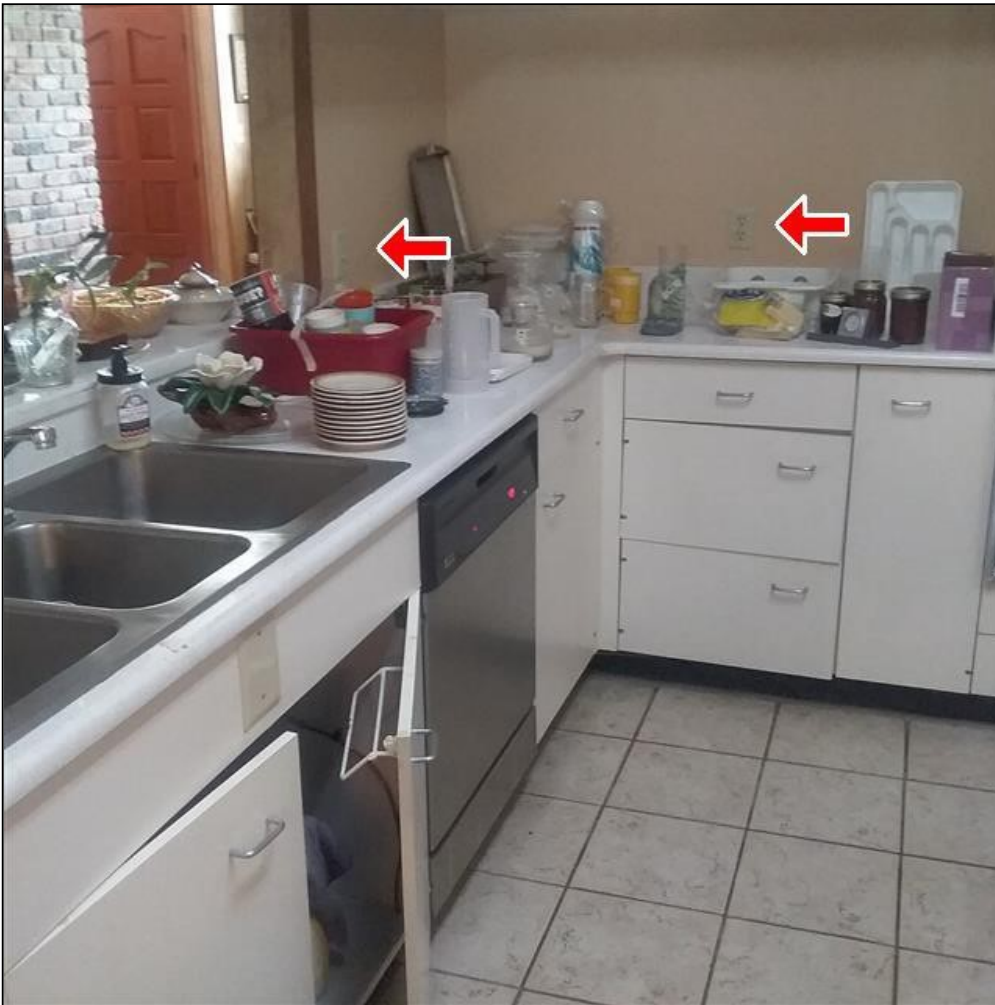
7.5 Item 6(Picture) Receptacle needs to be changed to GFCI type receptacle.

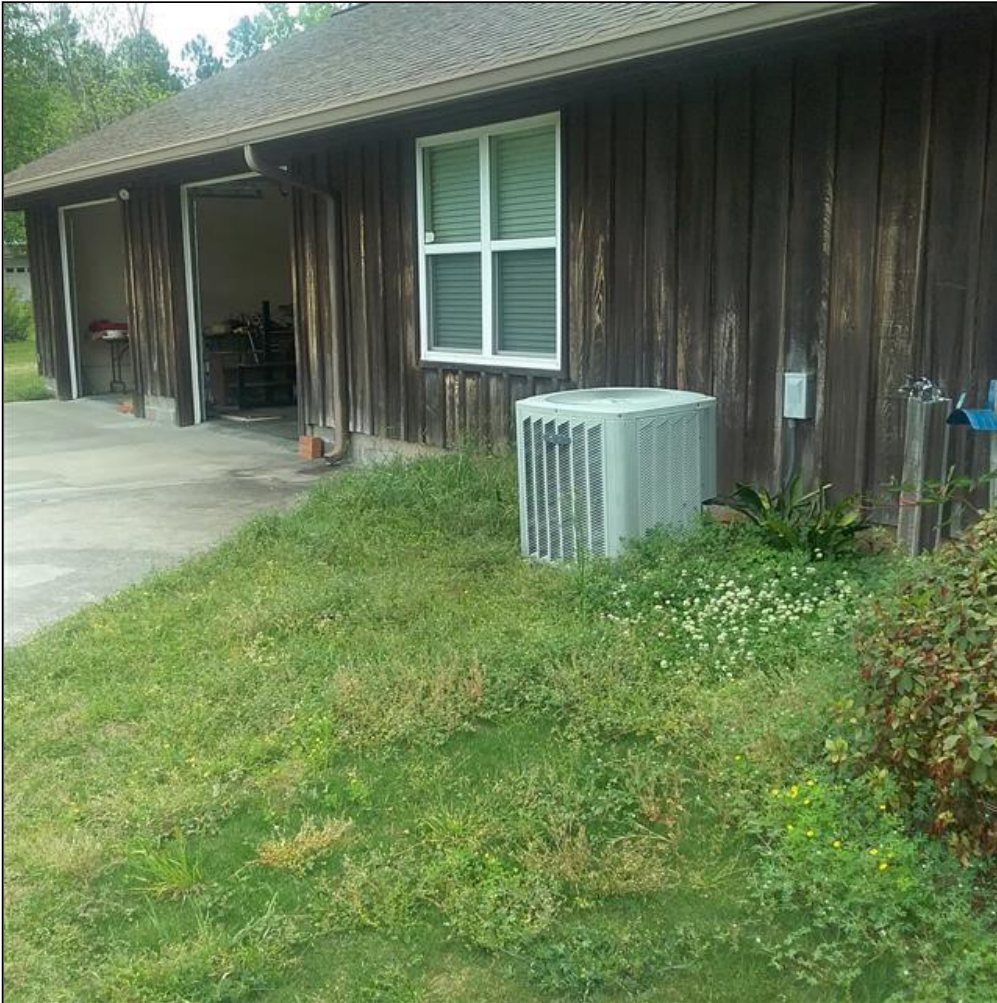
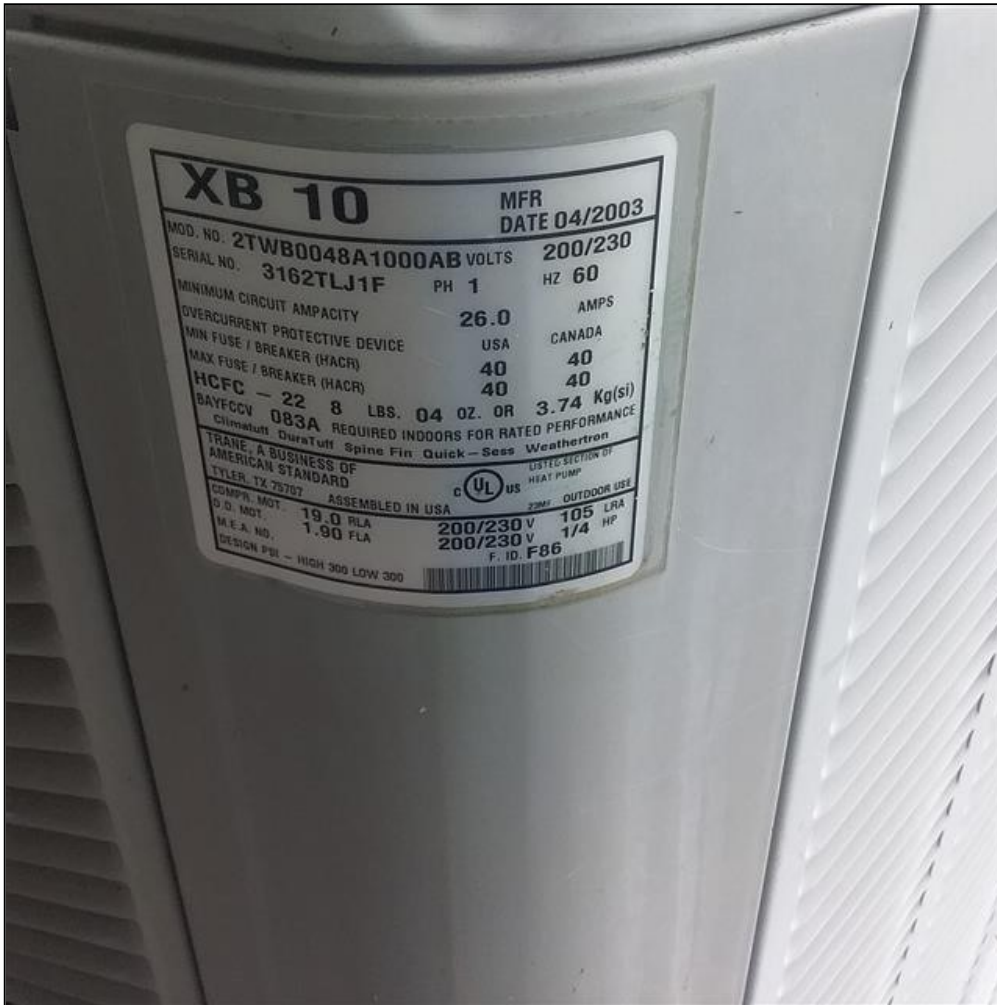
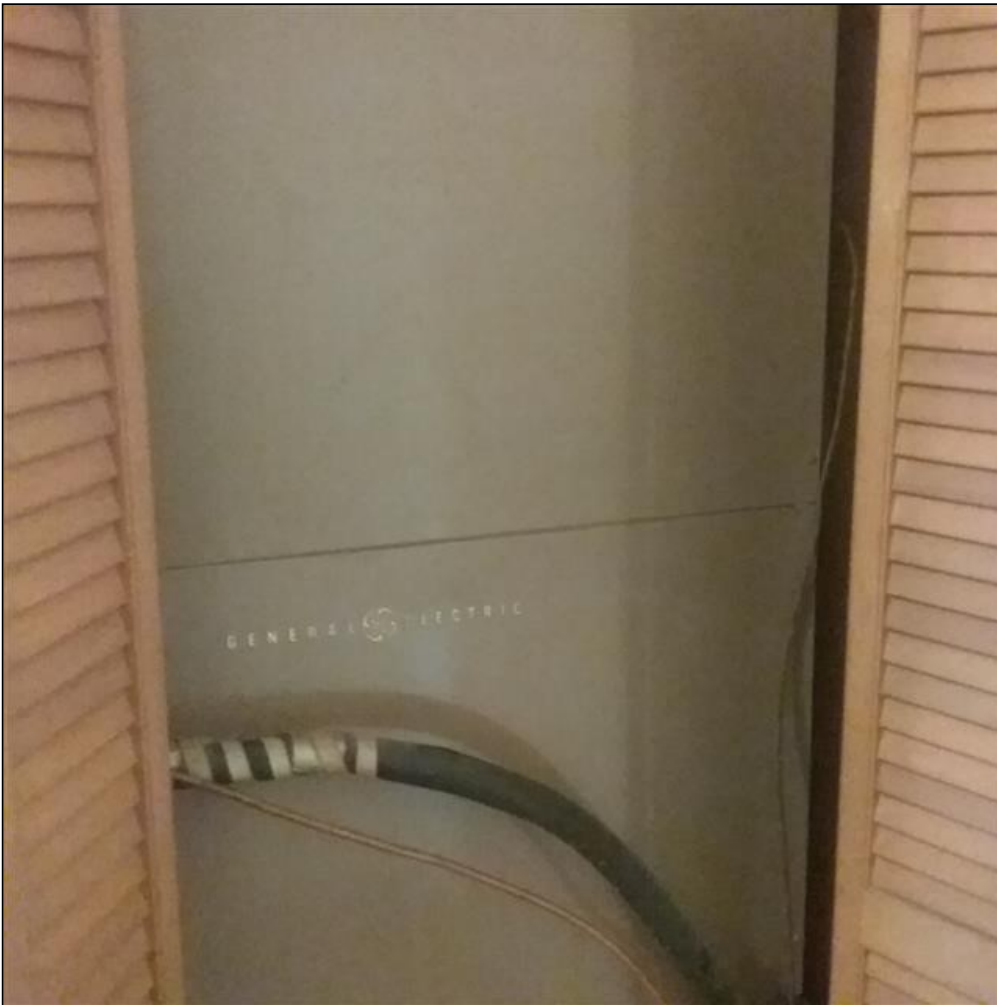
8.0 The HVAC system serving the middle portion of home is at end of its expected service life, and will need to be replaced in the near future.

8.0 Item 1(Picture) The HVAC system serving the middle portion of home is at end of its expected service life, and will need to be replaced in the near future.

8.0 Item 2(Picture) The HVAC system serving the middle portion of home is at end of its expected service life, and will need to be replaced in the near future.

8.0 Item 3(Picture) The HVAC system serving the middle portion of home is at end of its expected service life, and will need to be replaced in the near future.

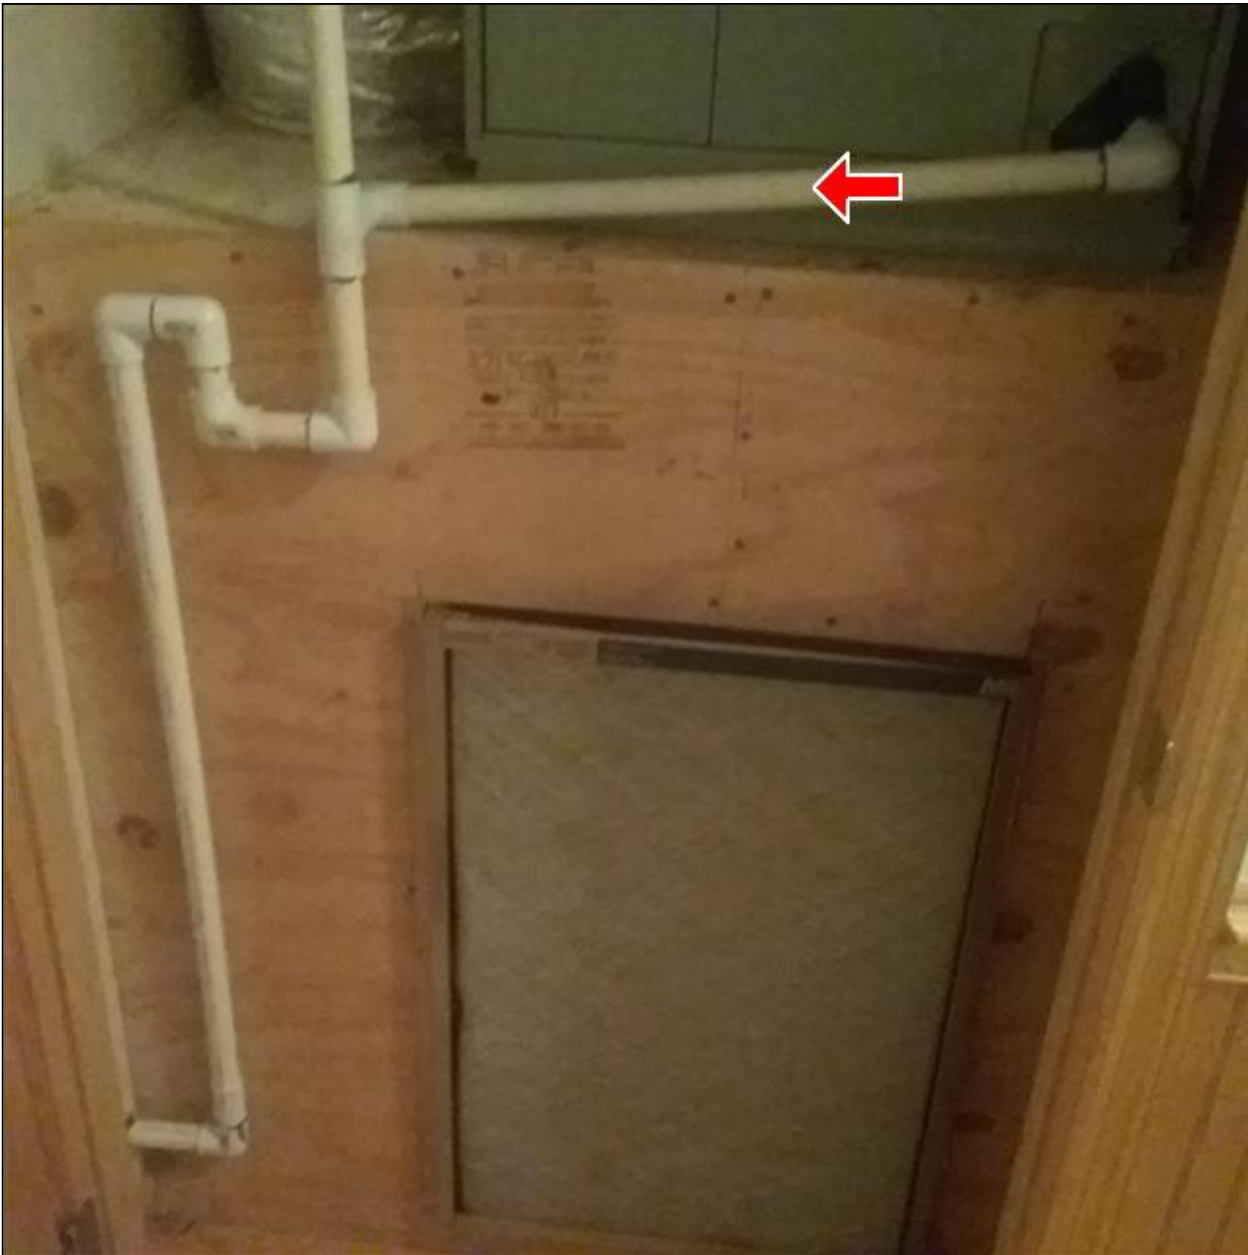
8.2 All HVAC air handlers need to have condensate water shut off sensors installed on the primary drains.

8.2 Item 1(Picture) All HVAC air handlers need to have condensate water shut off sensors installed on the primary drains.
