Inspection Report

South Auction Realty

Property Address:
1341 Old Wadley Road
Swainboro Ga

Date: 4/13/2022	Time:	Report ID:
Property: 1341 Old Wadley Road Swainboro Ga	Customer: South Auction Realty	Real Estate Professional:

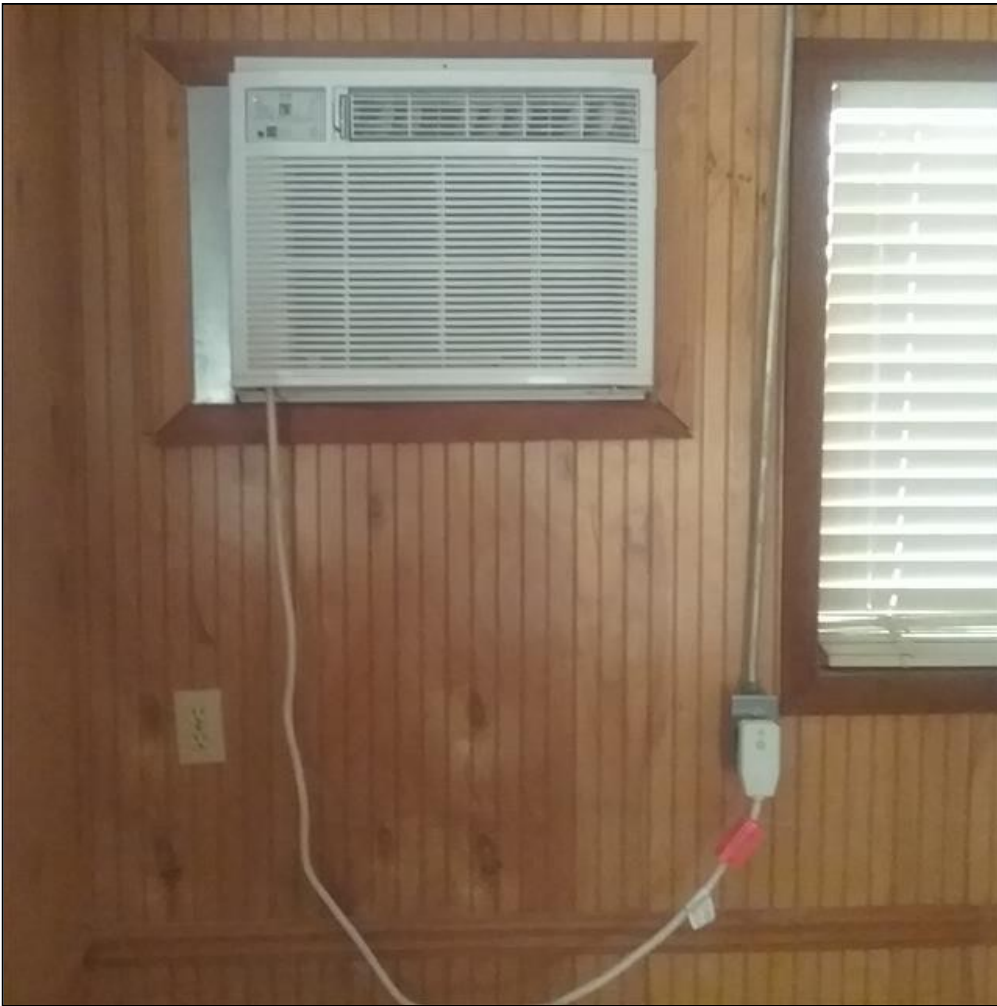
8.8 (1) Window AC unit in front of cottage not functioning when tested.

8.8 Item 1(Picture) Window AC unit in front of cottage not functioning when tested.

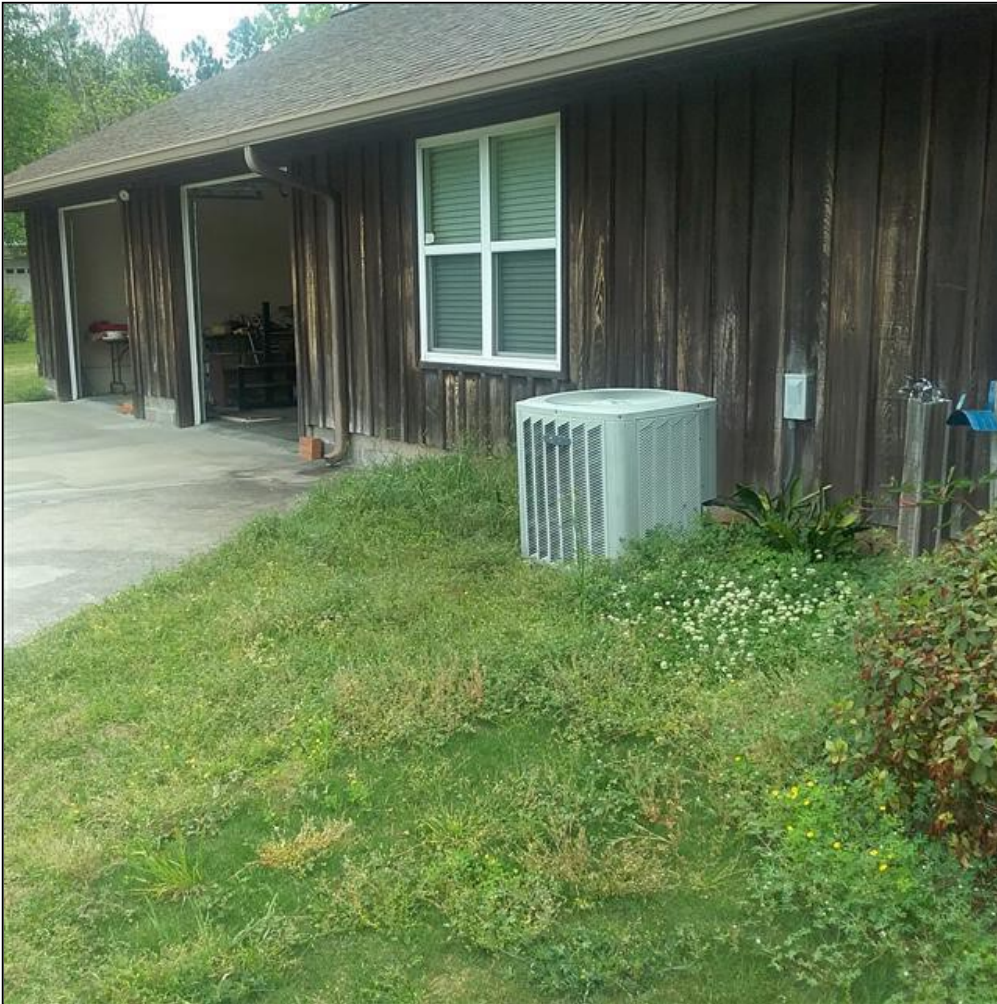
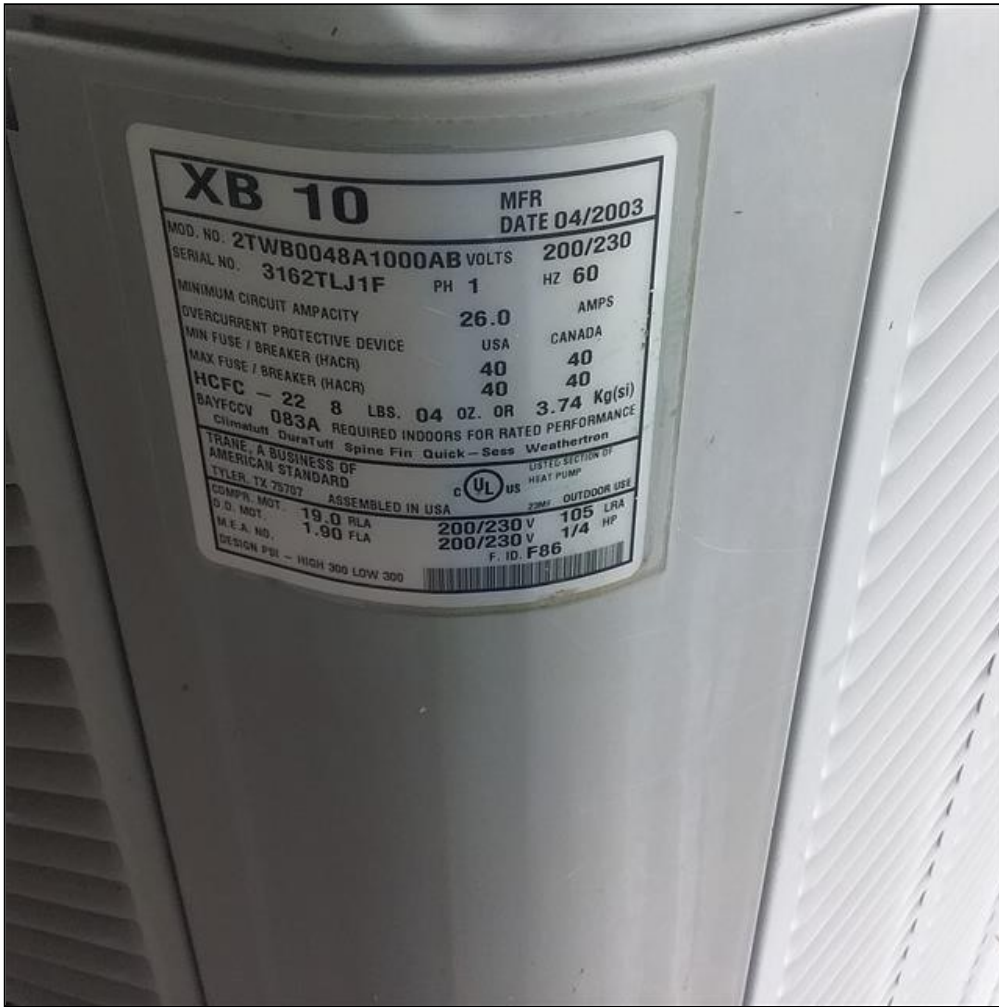
8.8 (2) The HVAC system serving the middle portion of home is at end of its expected service life, and will need to be replaced in the near future.

8.8 Item 2(Picture) The HVAC system serving the middle portion of home is at end of its expected service life, and will need to be replaced in the near future.

8.8 Item 3(Picture) The HVAC system serving the middle portion of home is at end of its expected service life, and will need to be replaced in the near future.

8.8 Item 4(Picture) The HVAC system serving the middle portion of home is at end of its expected service life, and will need to be replaced in the near future.

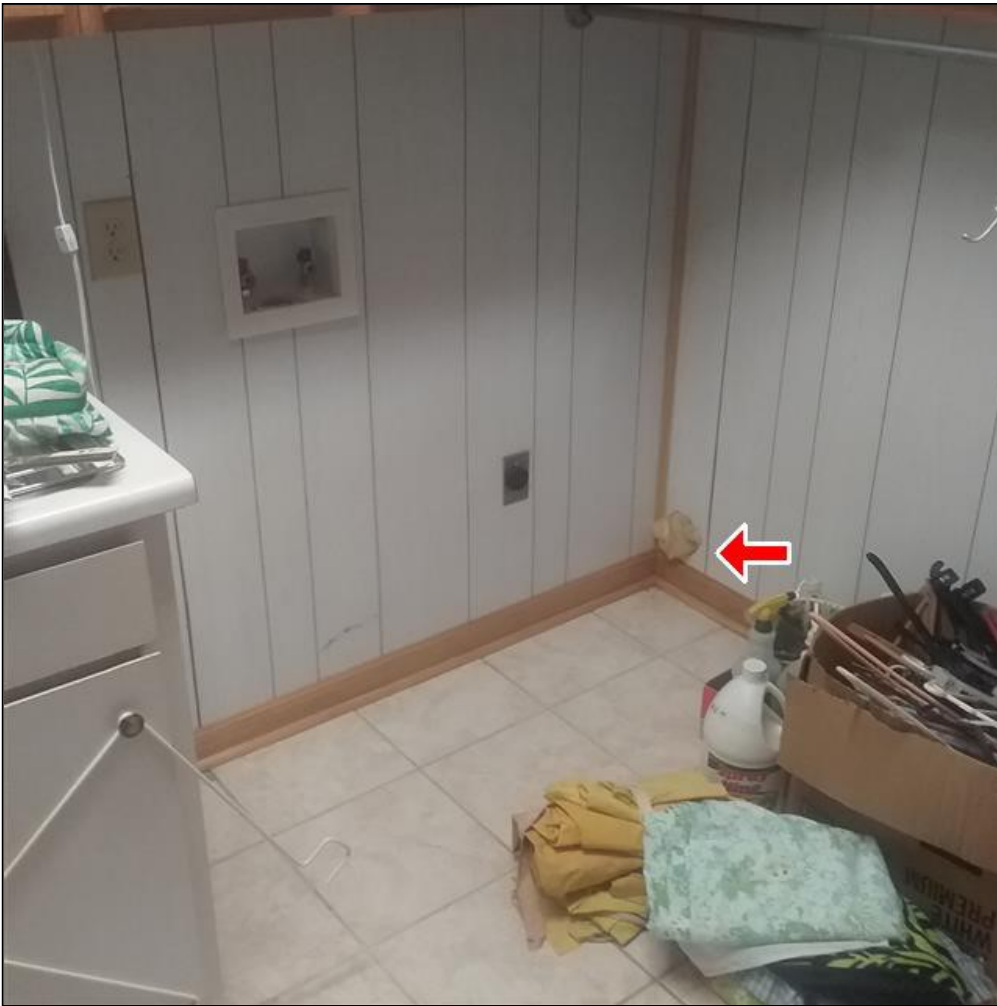
9.4 (2) There is no dryer vent stub kit installed.

9.4 Item 2(Picture) There is no dryer vent stub kit installed.

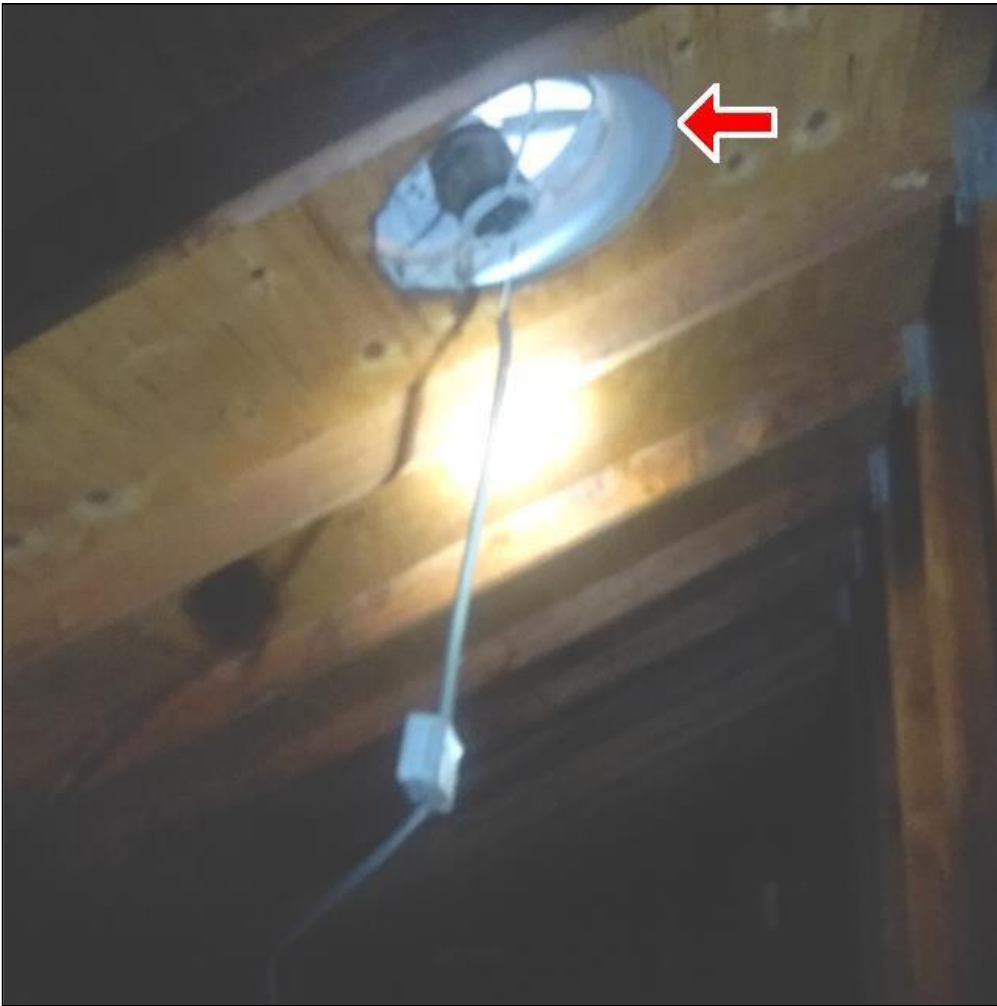
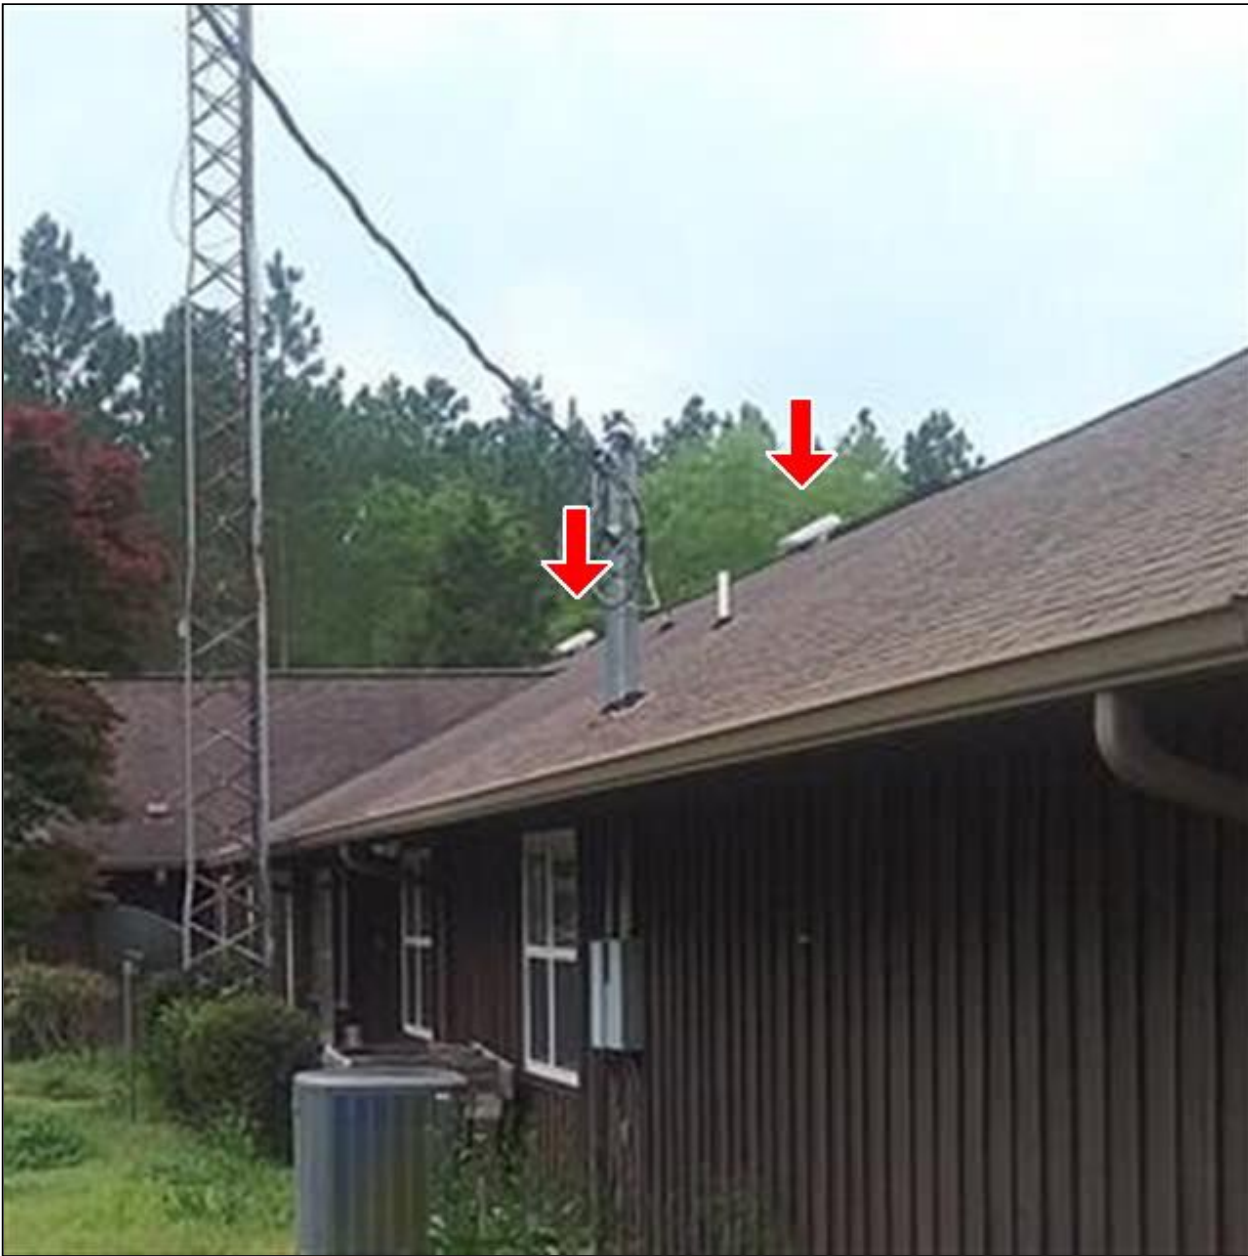
9.5 Both roof attic power ventilator motors are bad, and need to be replaced.

9.5 Item 1(Picture) Both roof attic power ventilator motors are bad, and need to be replaced.

9.5 Item 2(Picture) Both roof attic power ventilator motors are bad, and need to be replaced.

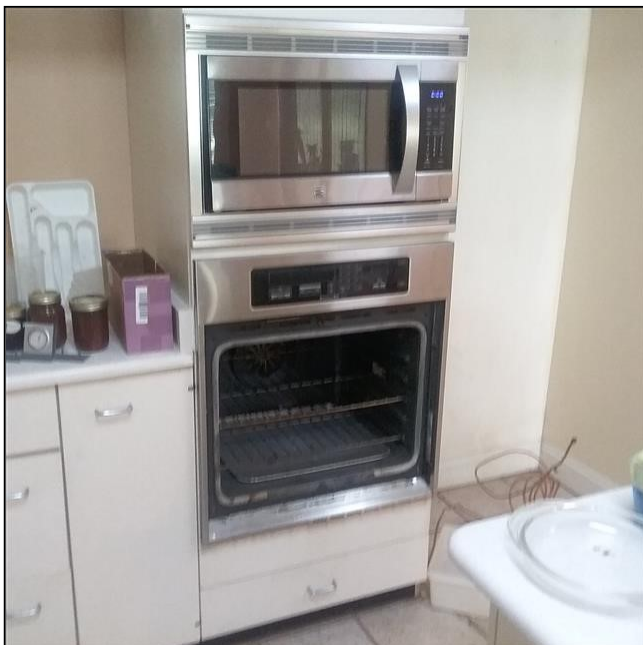
10.1 Item 1(Picture)

10.1 Oven door needs to be replaced.

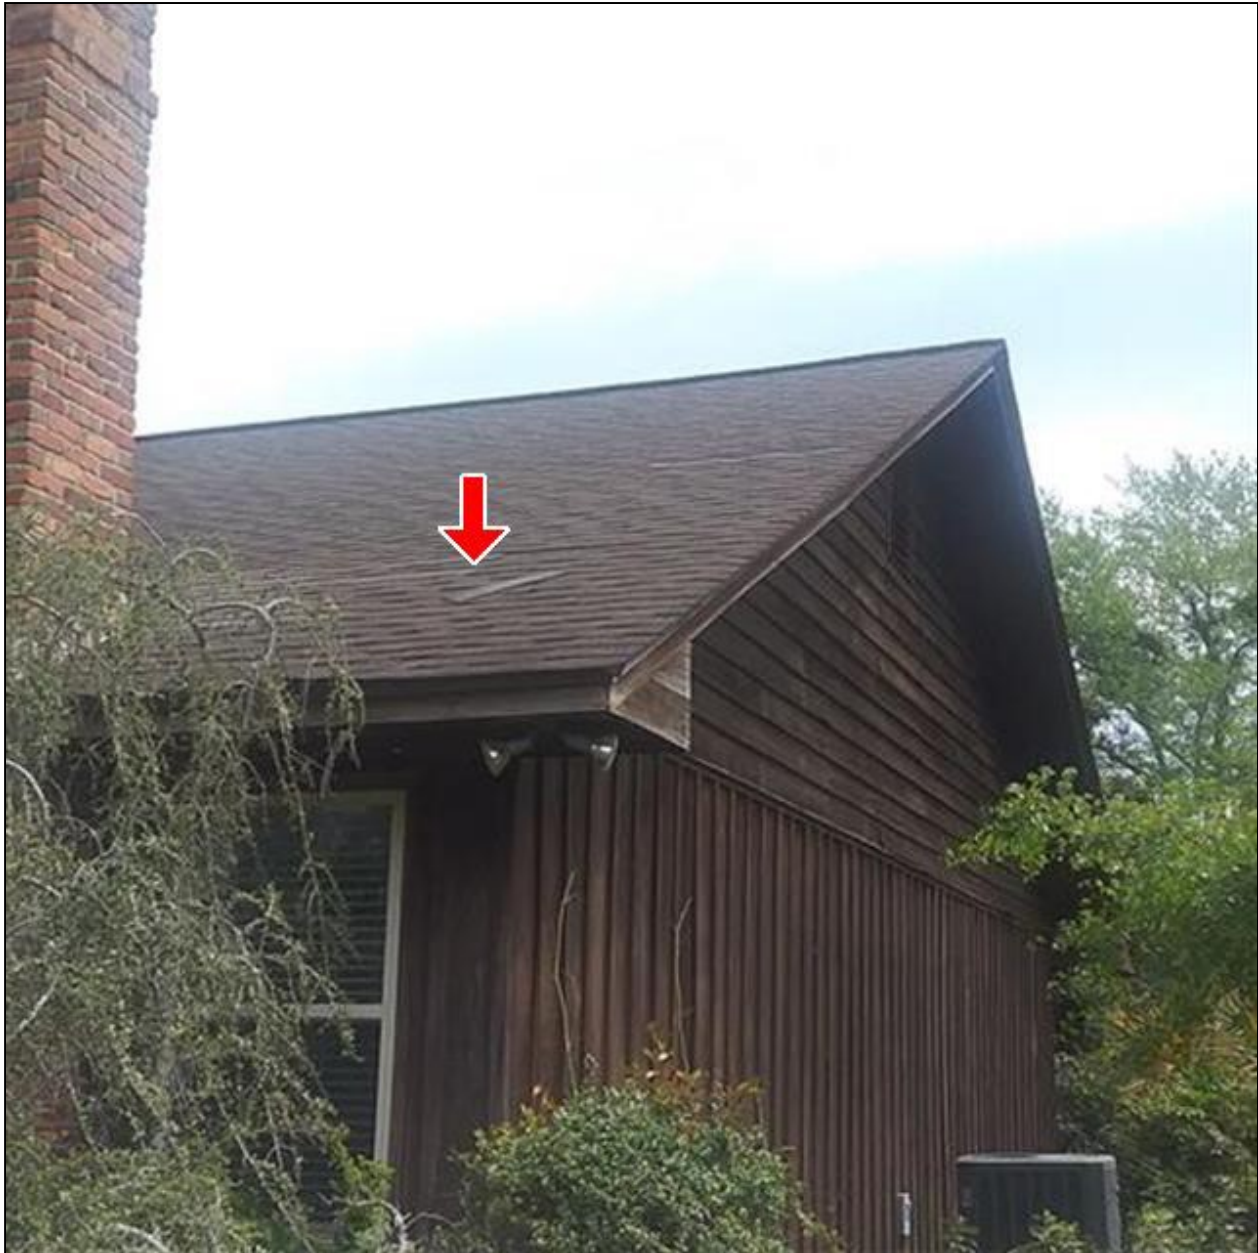
(1) The roofing has a shingle loose to the right side of home.

1.0 Item 1(Picture) The roofing has a shingle loose to the right side of home.
(2) Cottage roof gutter needs to be straightened or replaced.

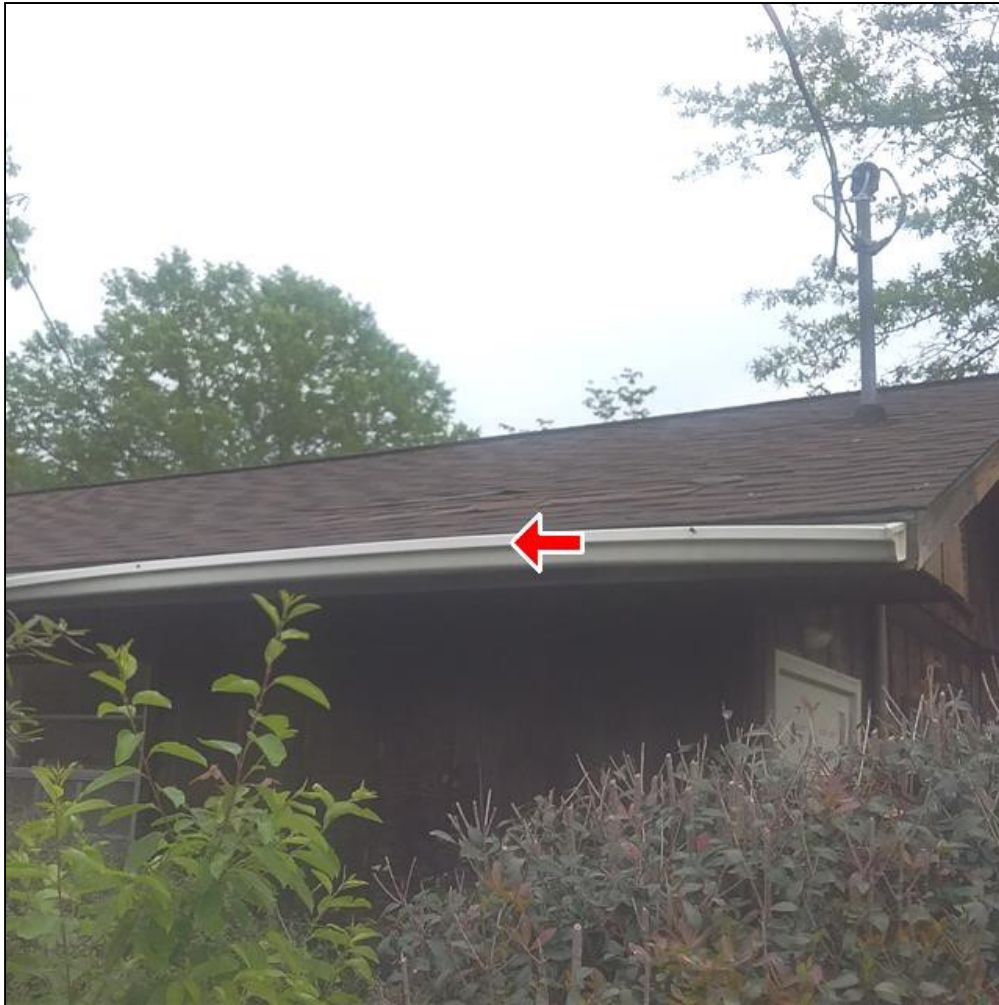
1.0 Item 2(Picture) Cottage roof gutter needs to be straightened or replaced.

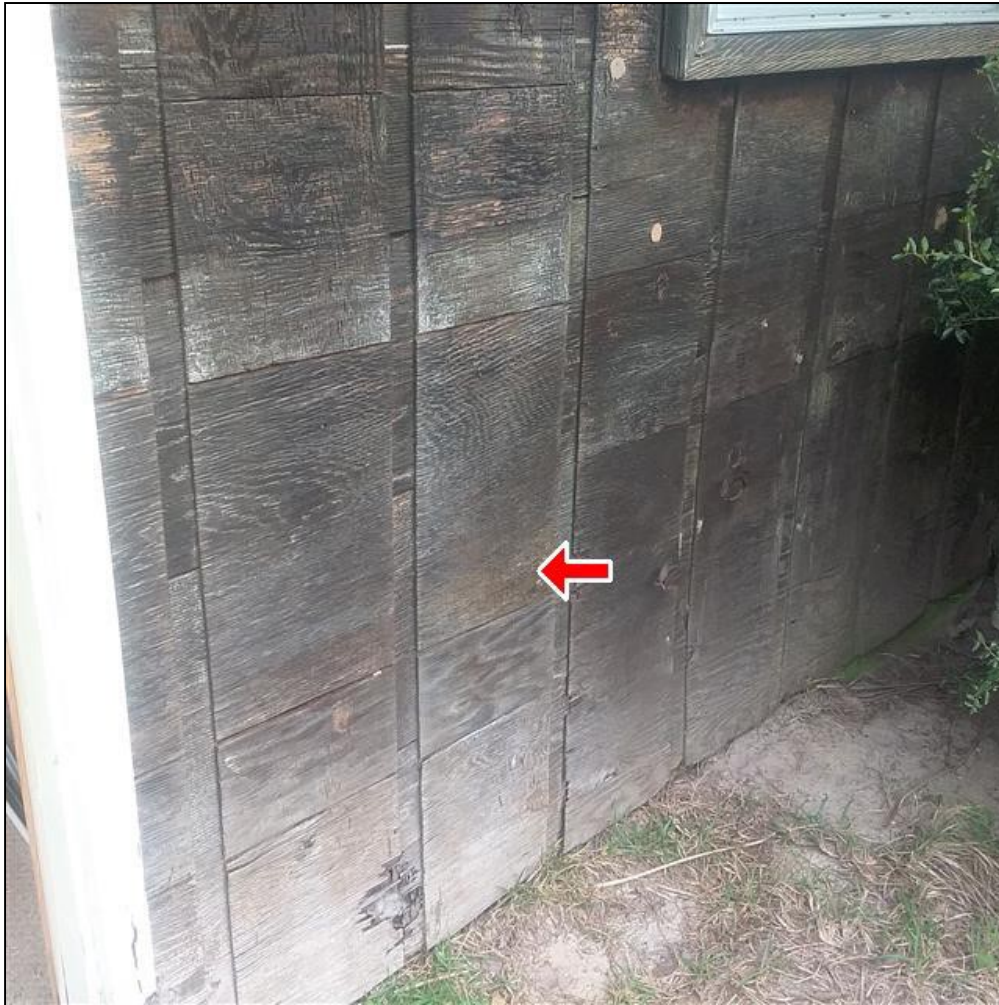
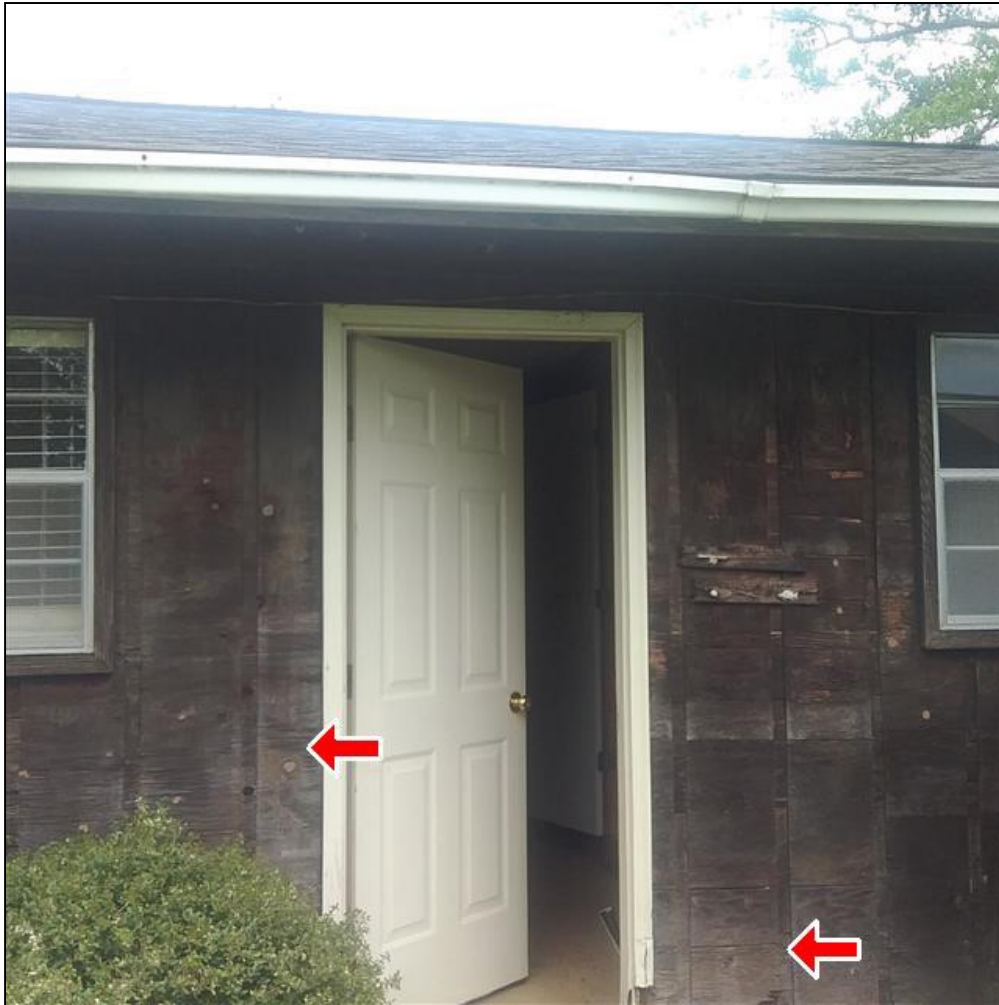
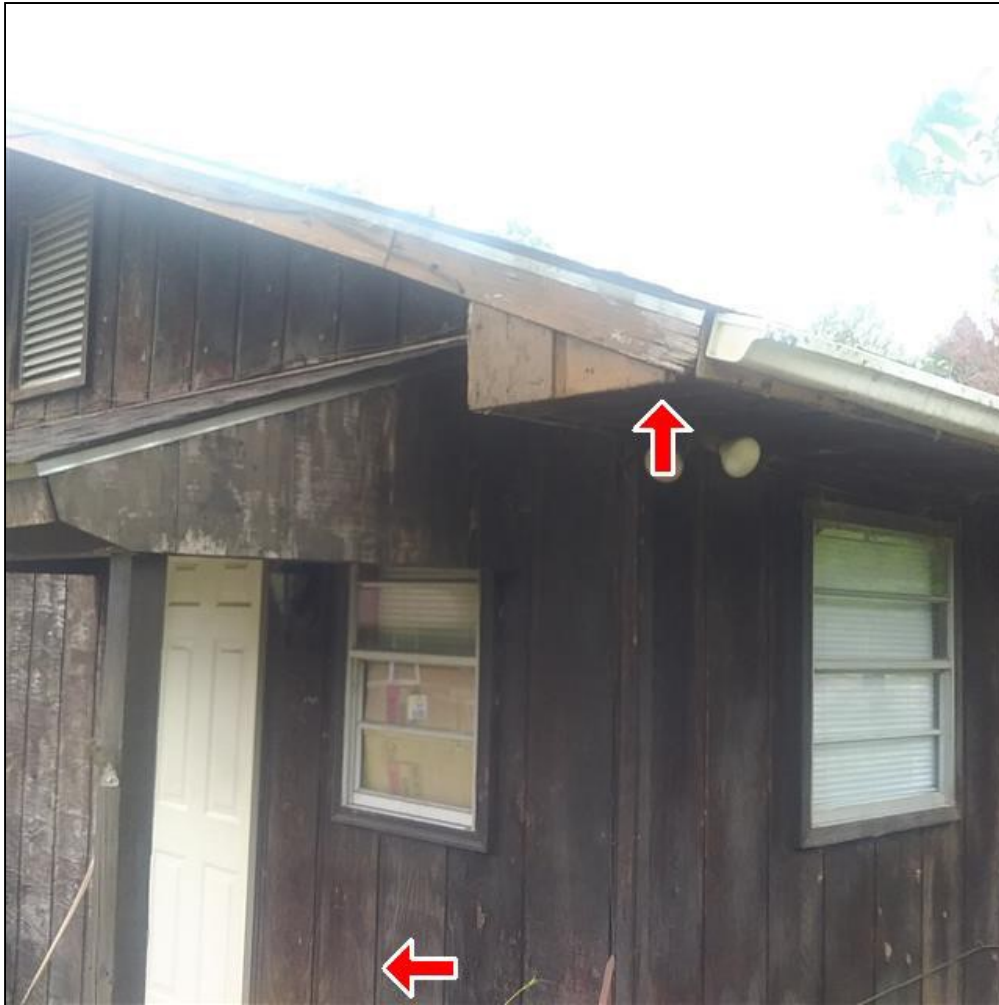
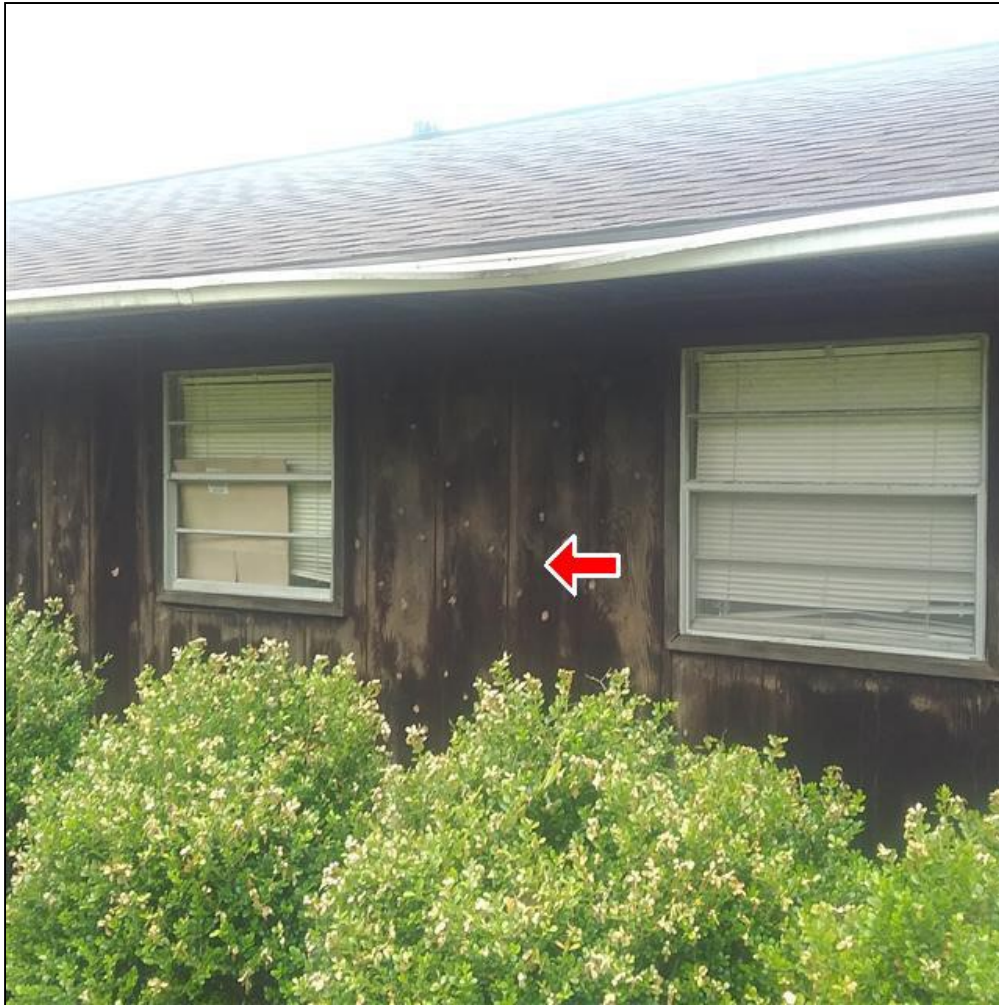
Exterior wall siding, trim, and fascia on Cottage needs to be painted or stained to prevent wood rot.

2.0 Item 1(Picture) Exterior wall siding, trim, and fascia on Cottage needs to be painted or stained to prevent wood rot.

2.0 Item 2(Picture) Exterior wall siding, trim, and fascia on Cottage needs to be painted or stained to prevent wood rot.

2.0 Item 3(Picture) Exterior wall siding, trim, and fascia on Cottage needs to be painted or stained to prevent wood rot.

2.0 Item 4(Picture) Exterior wall siding, trim, and fascia on Cottage needs to be painted or stained to prevent wood rot.

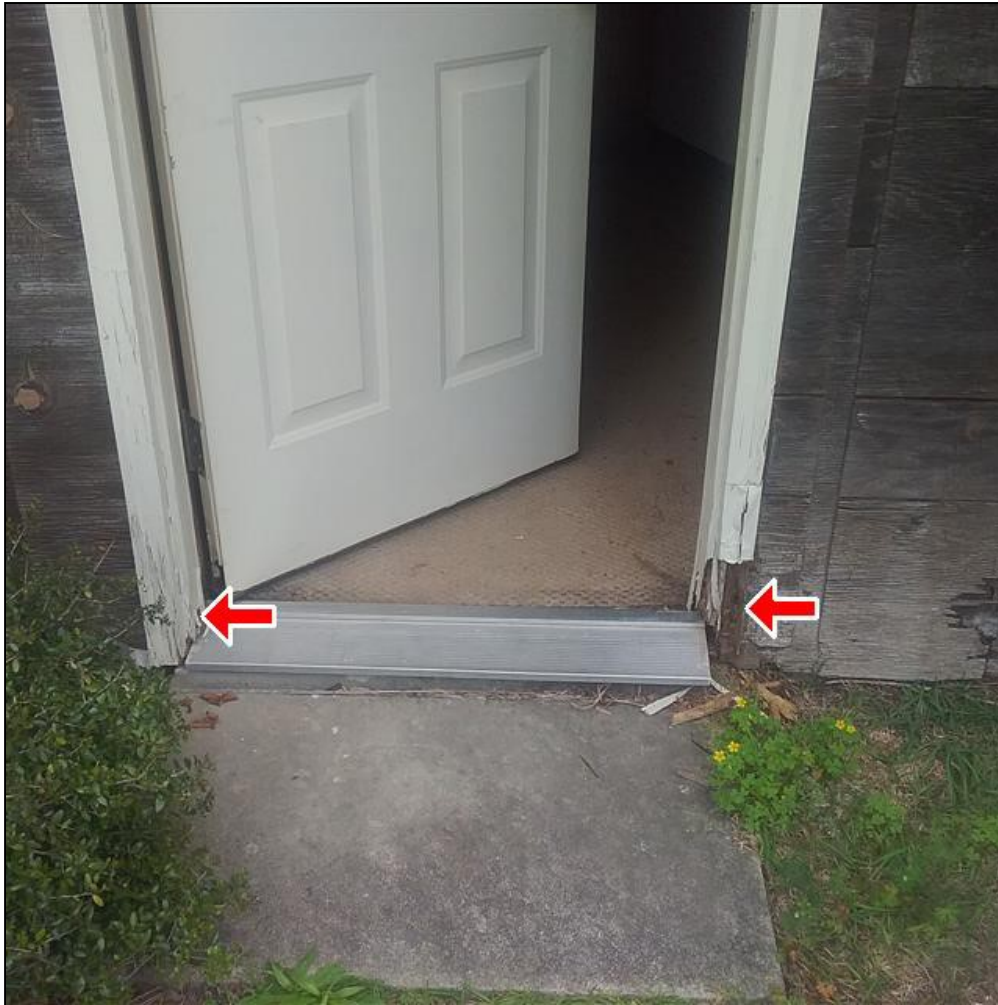
The wood door trim has water damage needing to be repaired, or replaced.

2.1 Item 1(Picture) The wood door trim has water damage needing to be repaired, or replaced.

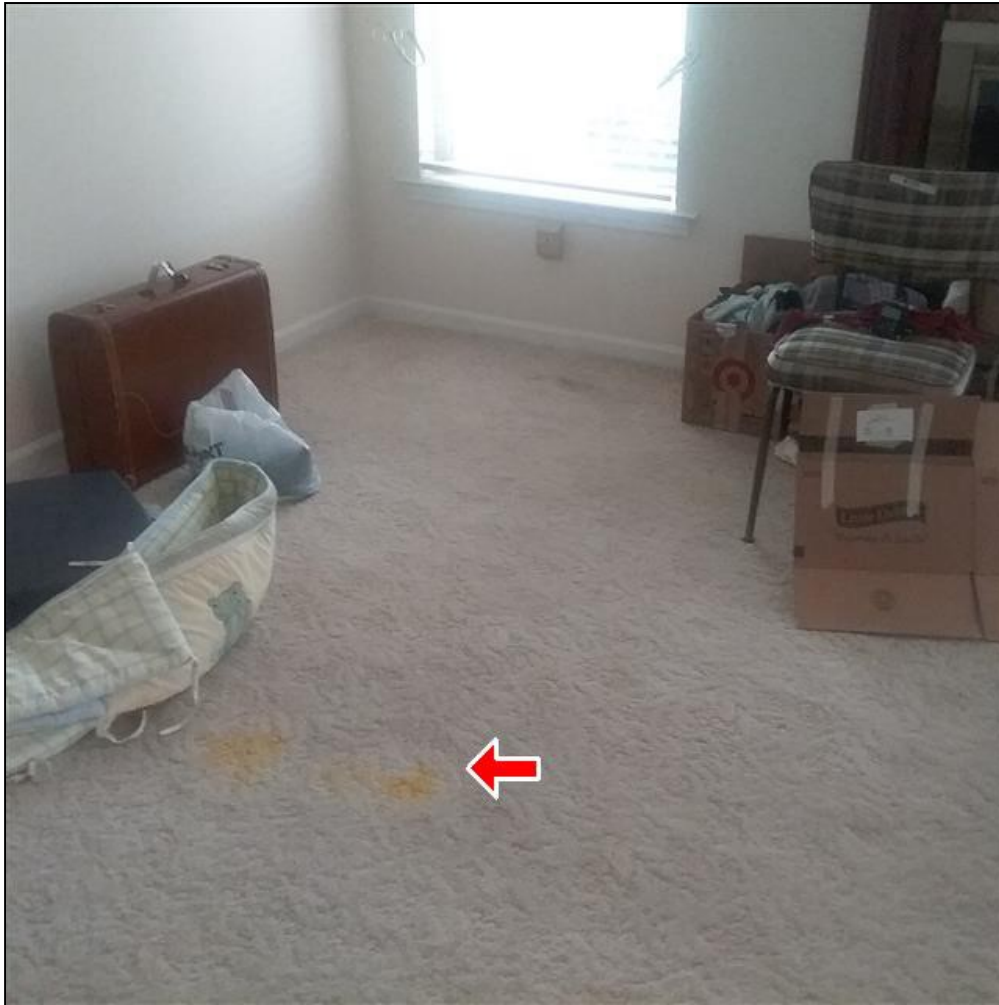
(1) Front right bedroom carpet needs to be replaced

4.2 Item 1(Picture) Front right bedroom carpet needs to be replaced
(2) The carpet in Cottage needs to be replaced.

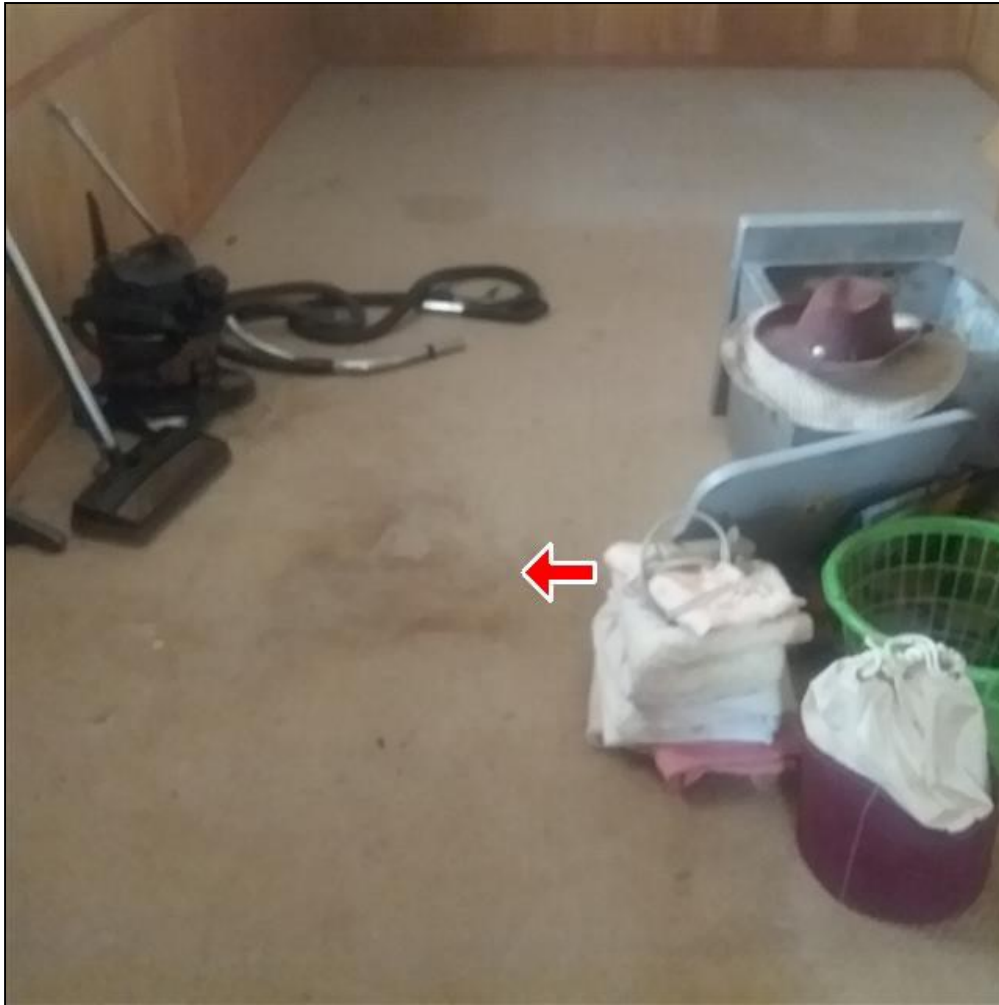
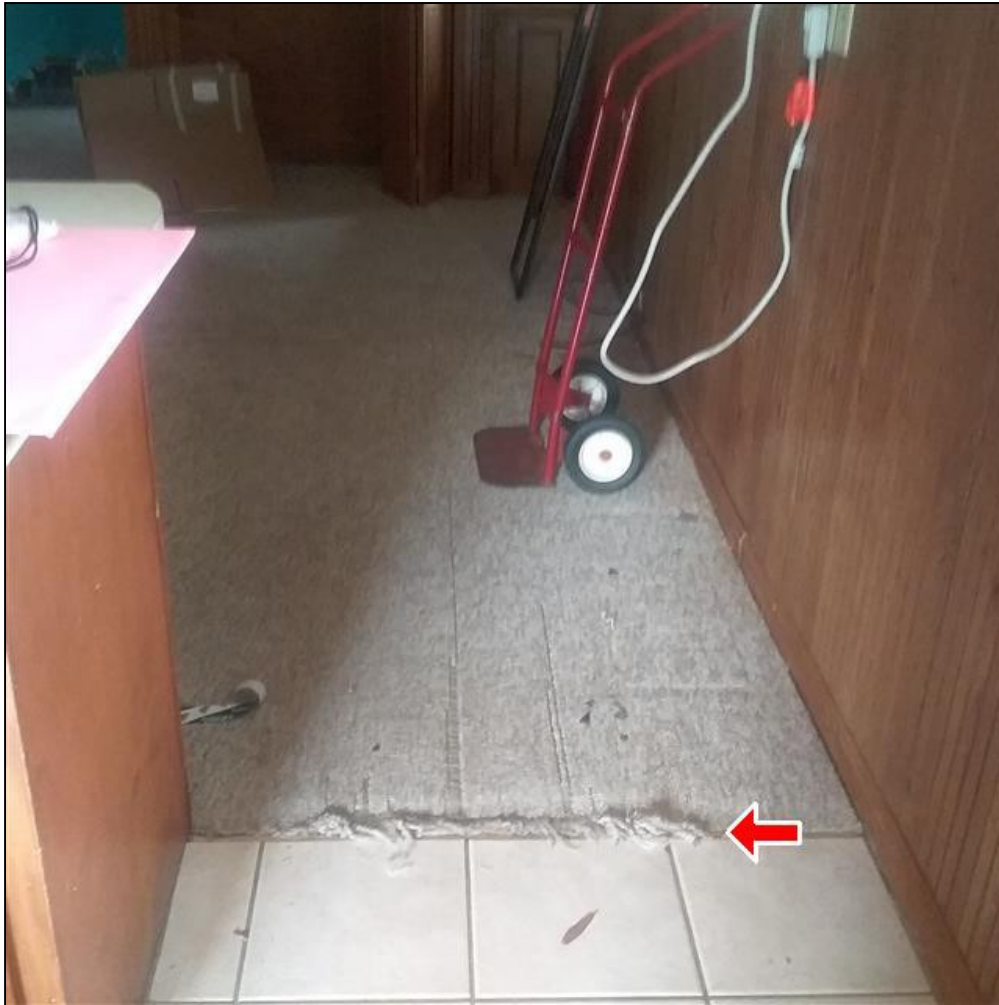
4.2 Item 2(Picture) The carpet in Cottage needs to be replaced.

4.2 Item 3(Picture) The carpet in Cottage needs to be replaced.

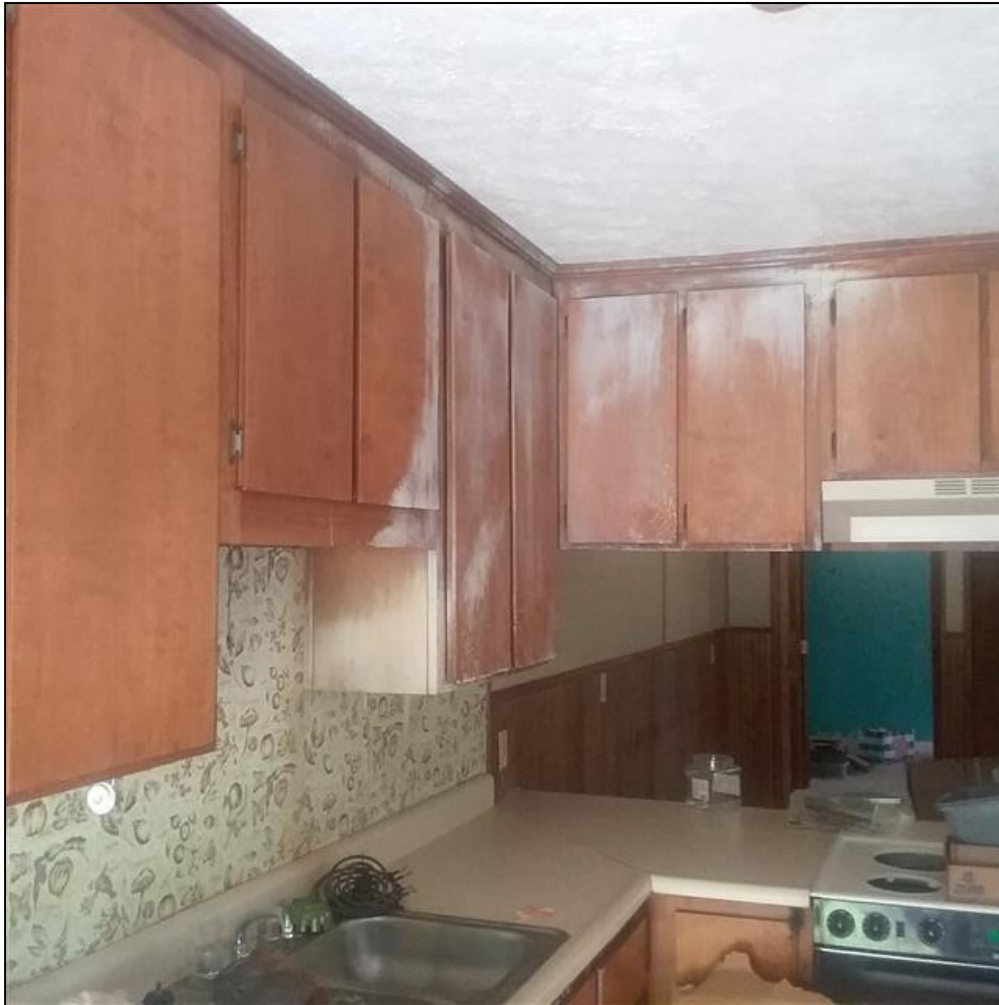
Cottage cabinets need to be cleaned, and re-stained.

4.4 Item 1(Picture) Cottage cabinets need to be cleaned, and re-stained.

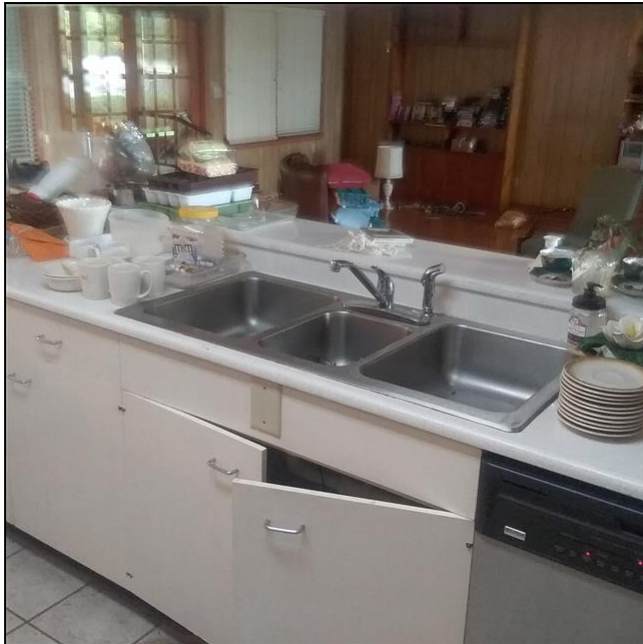
(1) The hot water side of kitchen faucet did not function when tested.

6.1 Item 1(Picture) The hot water side of kitchen faucet did not function when tested.

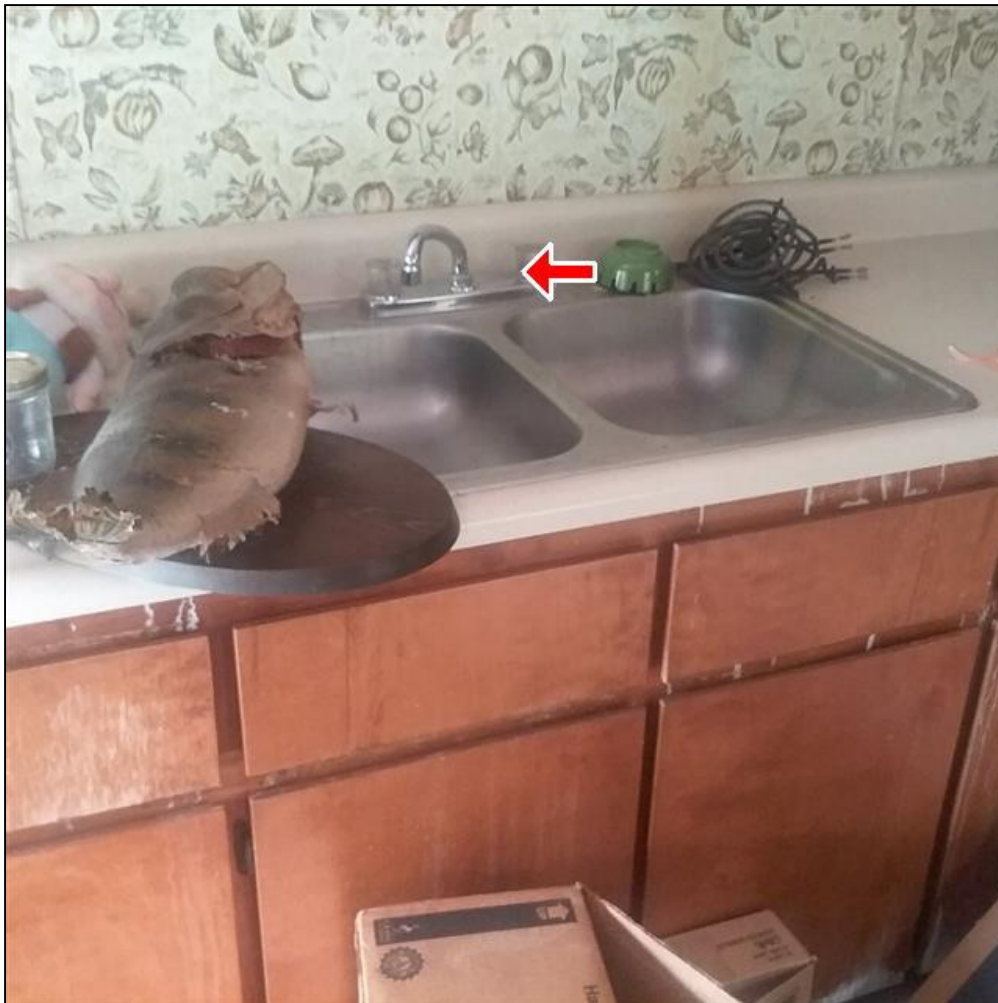
(2) The hot water side of Cottage kitchen faucet did not function when tested..

6.1 Item 2(Picture) The hot water side of Cottage kitchen faucet did not function when tested..

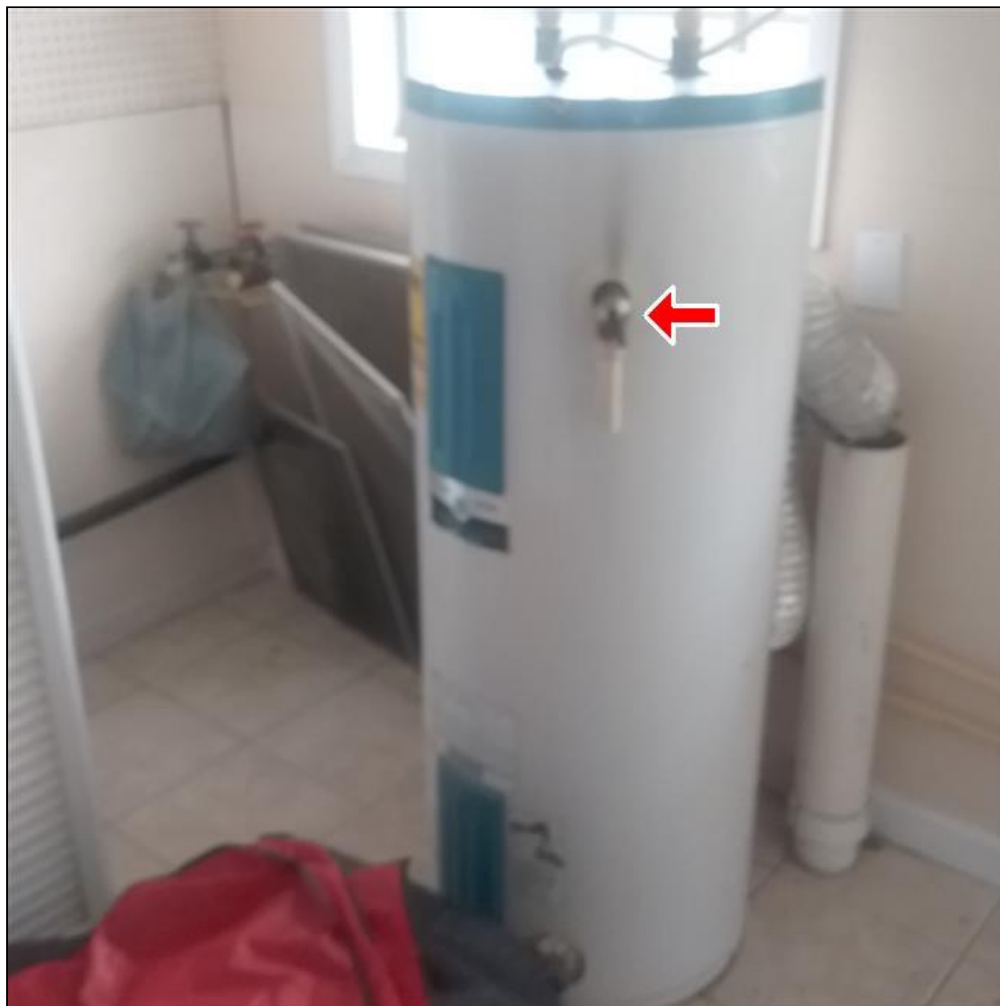
Cottage water heater needs to have pressure / temperature relief valve piped to exterior.

6.2 Item 1(Picture) Cottage water heater needs to have pressure / temperature relief valve piped to exterior.

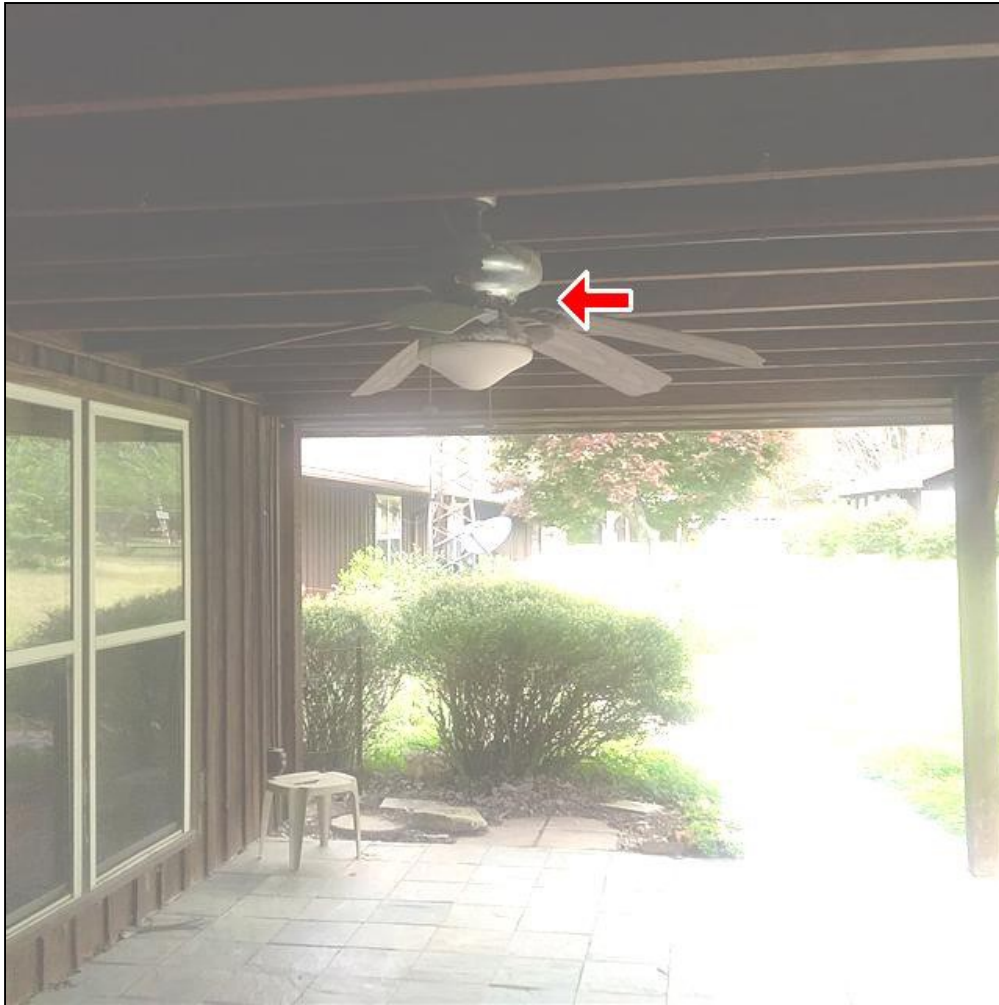
(1) The ceiling fan on the back needs to be replaced, as it has paint peeling off motor housing, and blades are drooping.

7.3 Item 1(Picture) The ceiling fan on the back needs to be replafed, as it has paint peeling off motor housing, and blades are drooping.
