Inspection Report

South Auction Realty

Property Address:
1341 Old Wadley Road
Swainboro Ga

Date: 4/13/2022	Time:	Report ID:
Property: 1341 Old Wadley Road Swainboro Ga	Customer: South Auction Realty	Real Estate Professional:

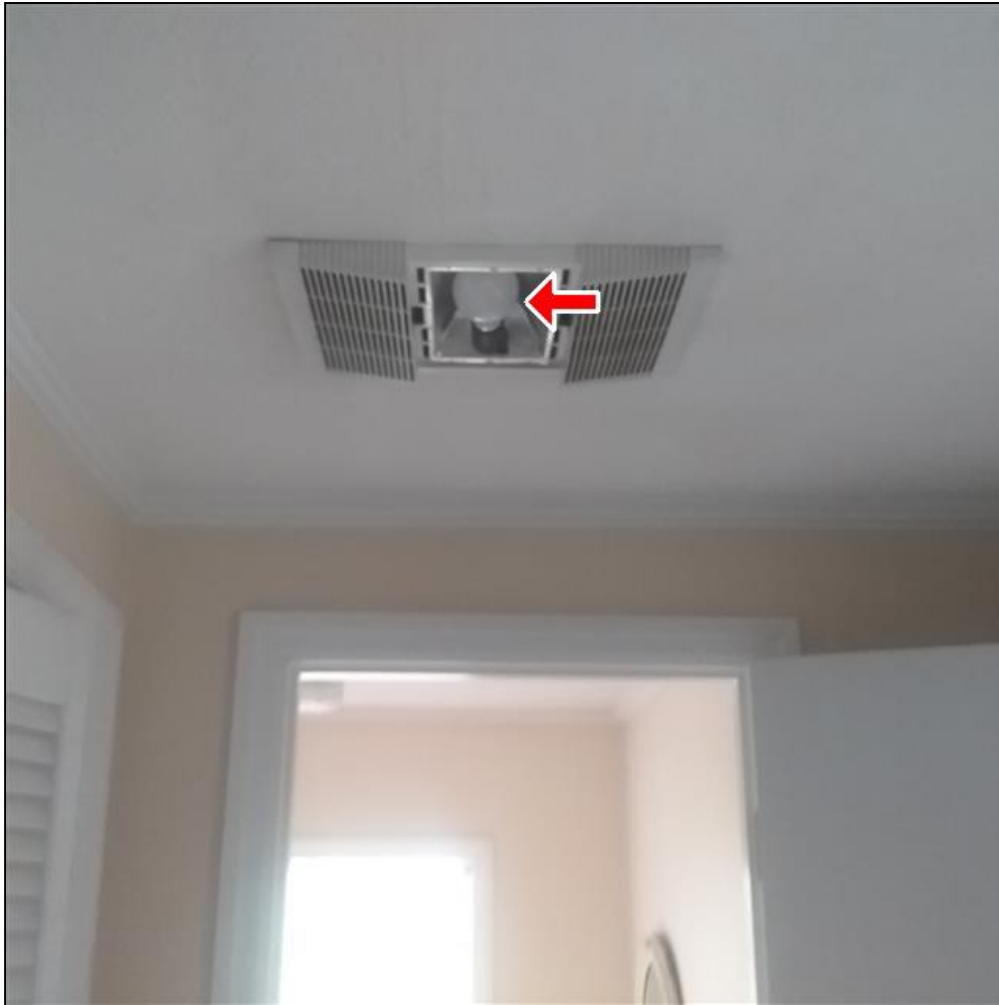
(2) Light needs cover in bathroom.

7.3 Item 3(Picture) Light needs cover in bathroom.

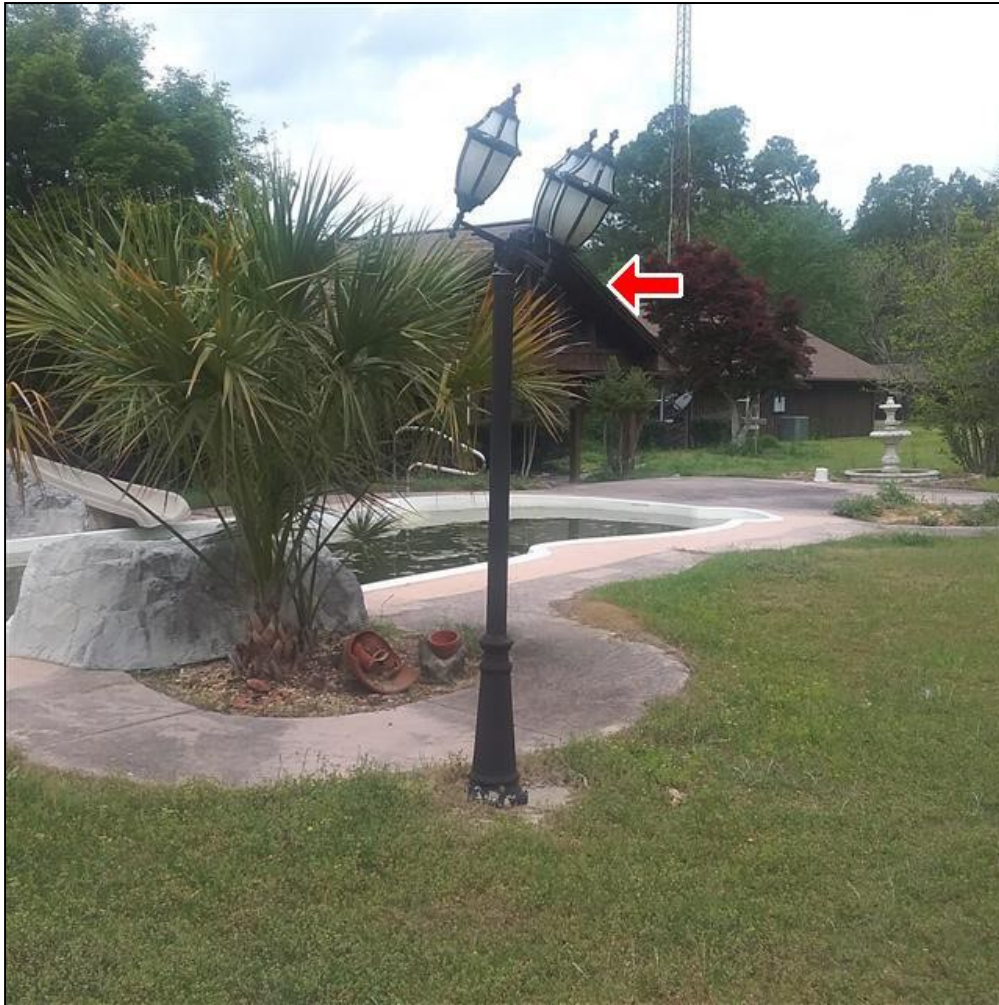
(3) The exterior post lamp needs repair.

7.3 Item 4(Picture) The exterior post lamp needs repair.

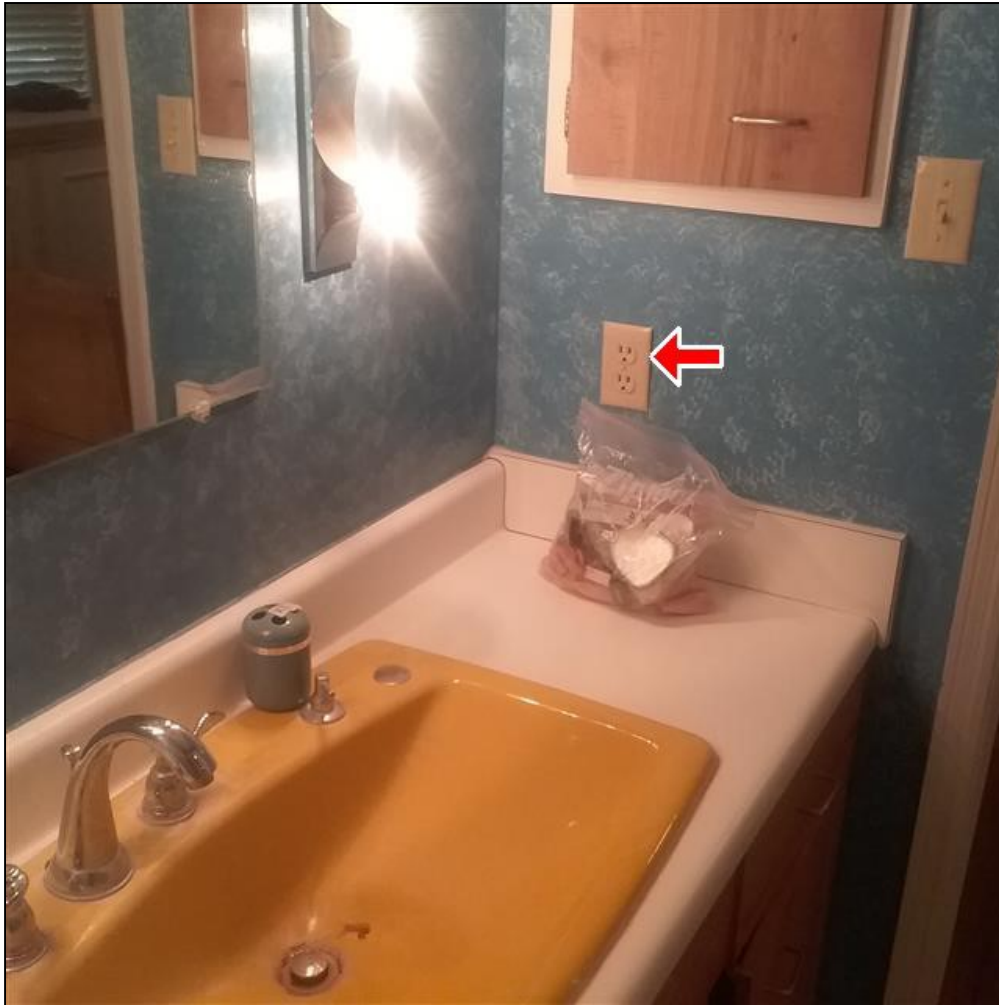
All electrical receptacles within 6 feet of water on interior, or any on exterior should be ground fault circuit protected.

7.5 Item 1(Picture) Receptacle needs to be changed to GFCI type receptacle.

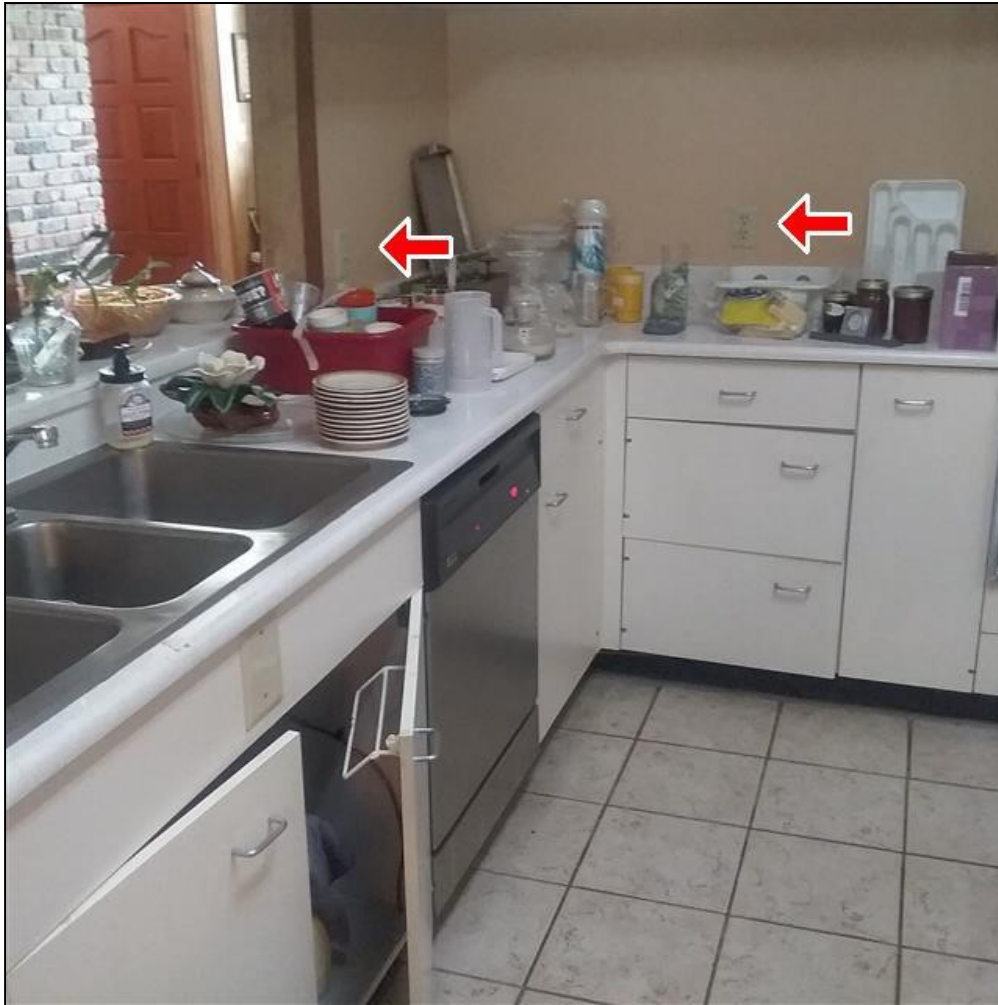
7.5 Item 6(Picture) Receptacle needs to be changed to GFCI type receptacle.

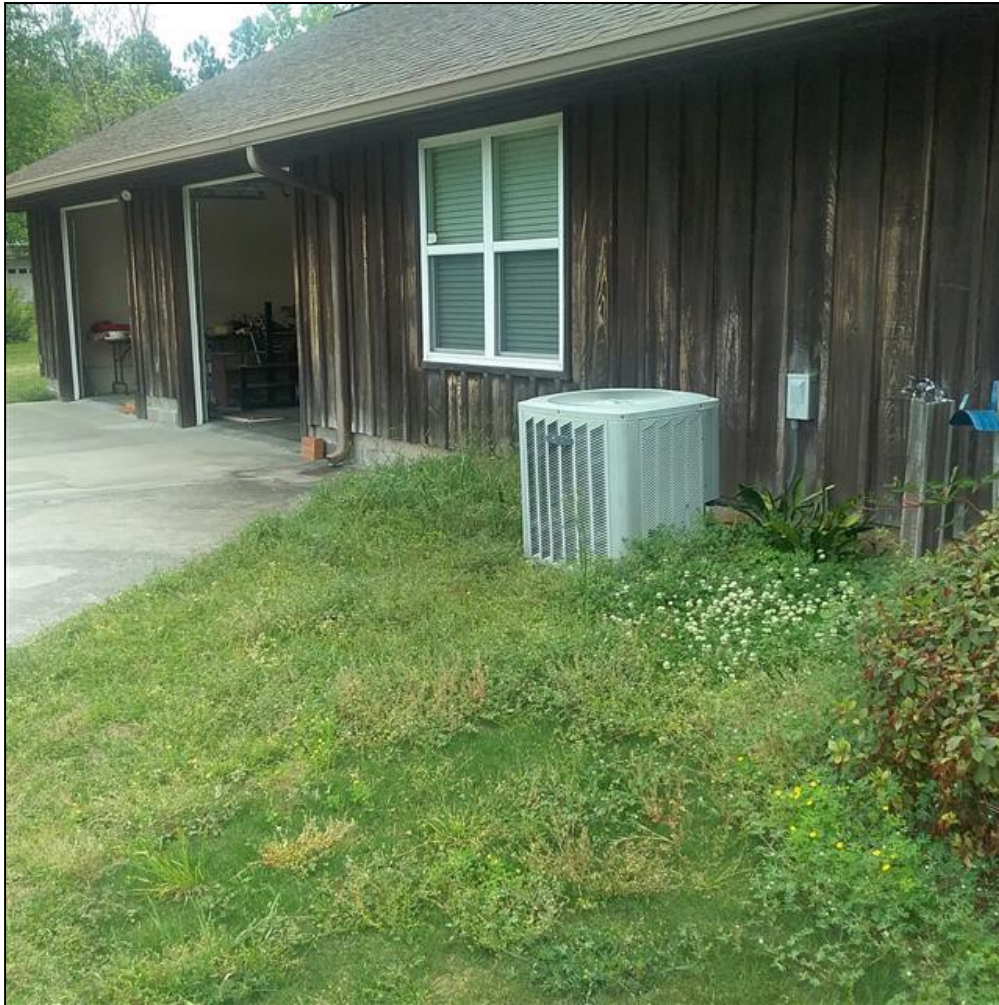
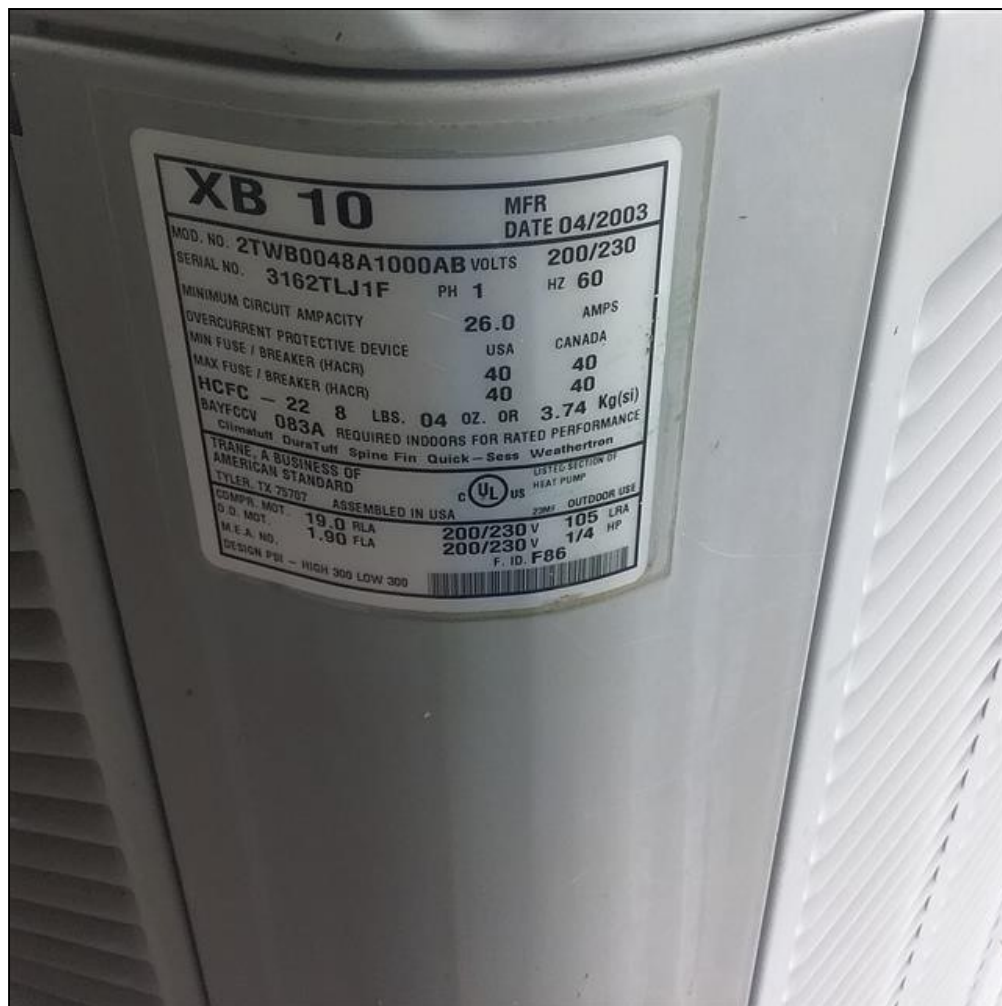
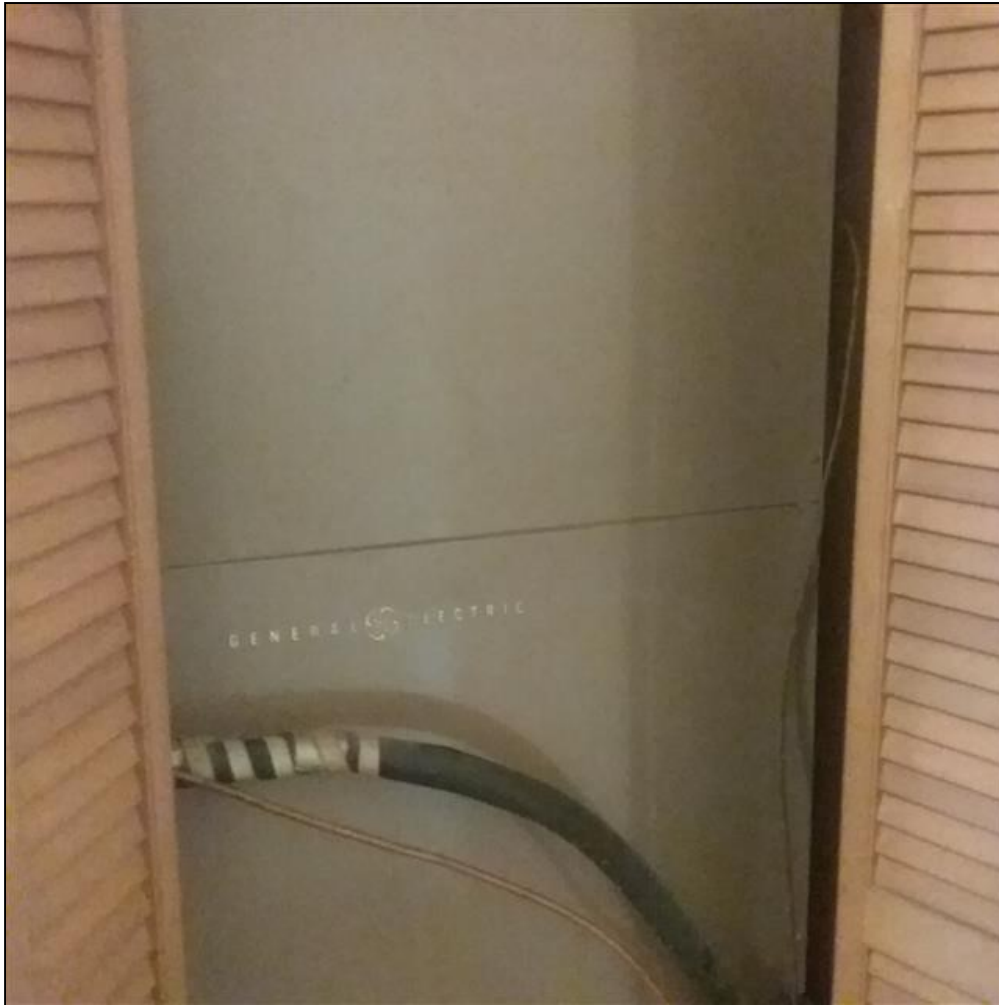
The HVAC system serving the middle portion of home is at end of its expected service life, and will need to be replaced in the near future.

8.0 Item 1(Picture) The HVAC system serving the middle portion of home is at end of its expected service life, and will need to be replaced in the near future.

8.0 Item 2(Picture) The HVAC system serving the middle portion of home is at end of its expected service life, and will need to be replaced in the near future.

8.0 Item 3(Picture) The HVAC system serving the middle portion of home is at end of its expected service life, and will need to be replaced in the near future.

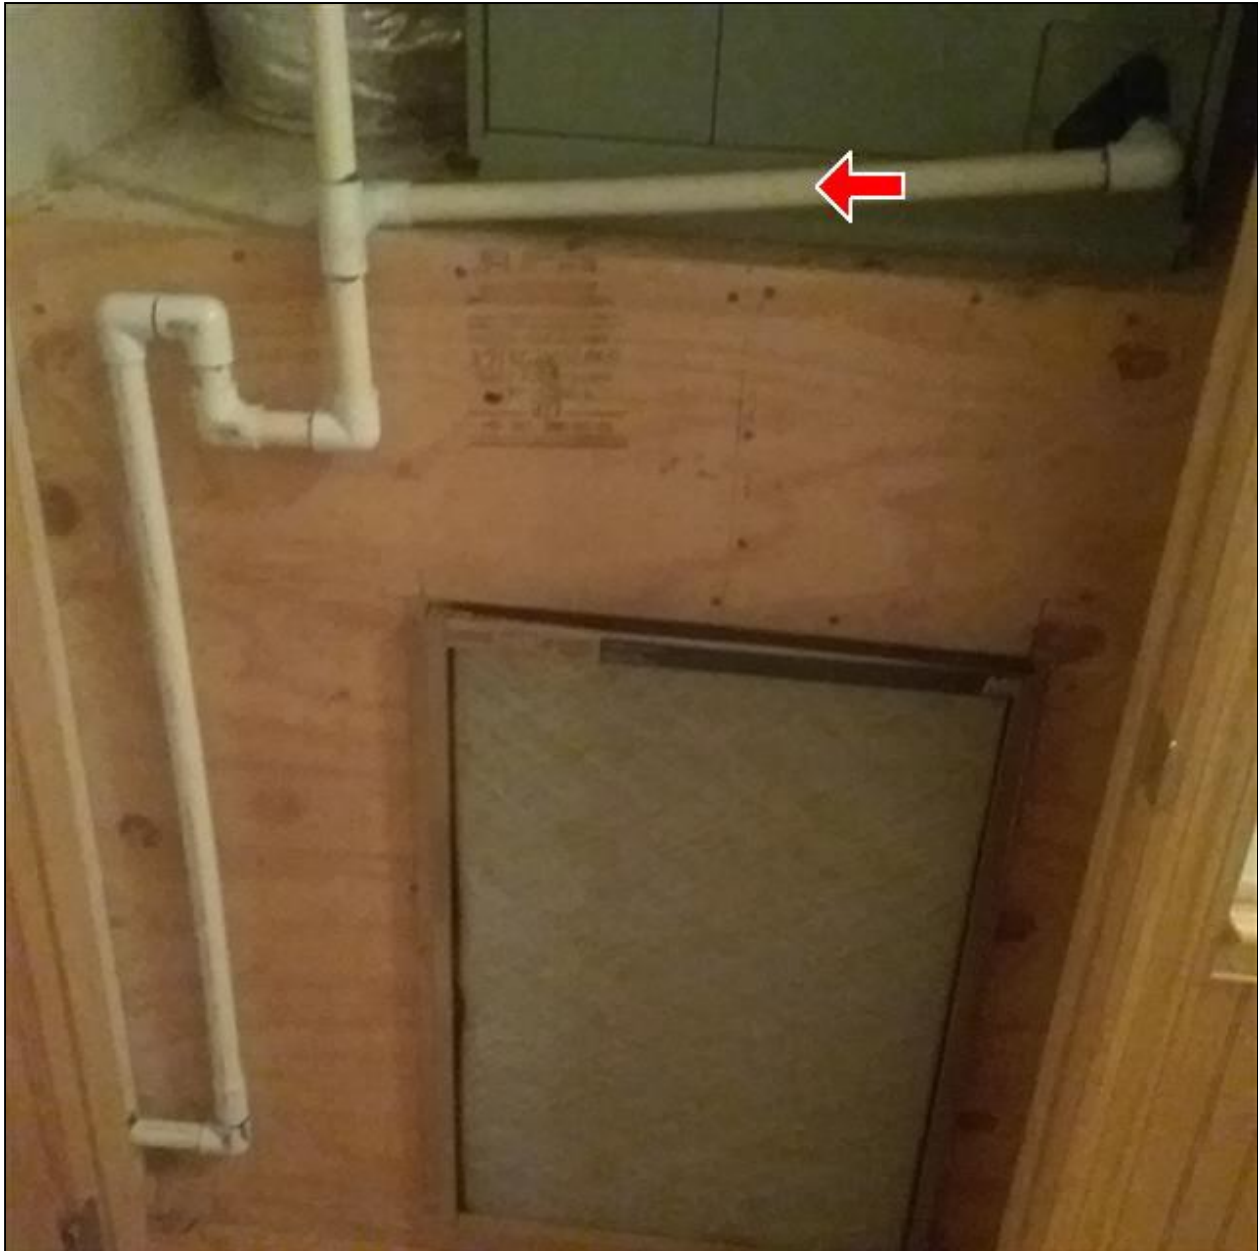
All HVAC air handlers need to have condensate water shut off sensors installed on the primary drains.

8.2 Item 1(Picture) All HVAC air handlers need to have condensate water shut off sensors installed on the primary drains.

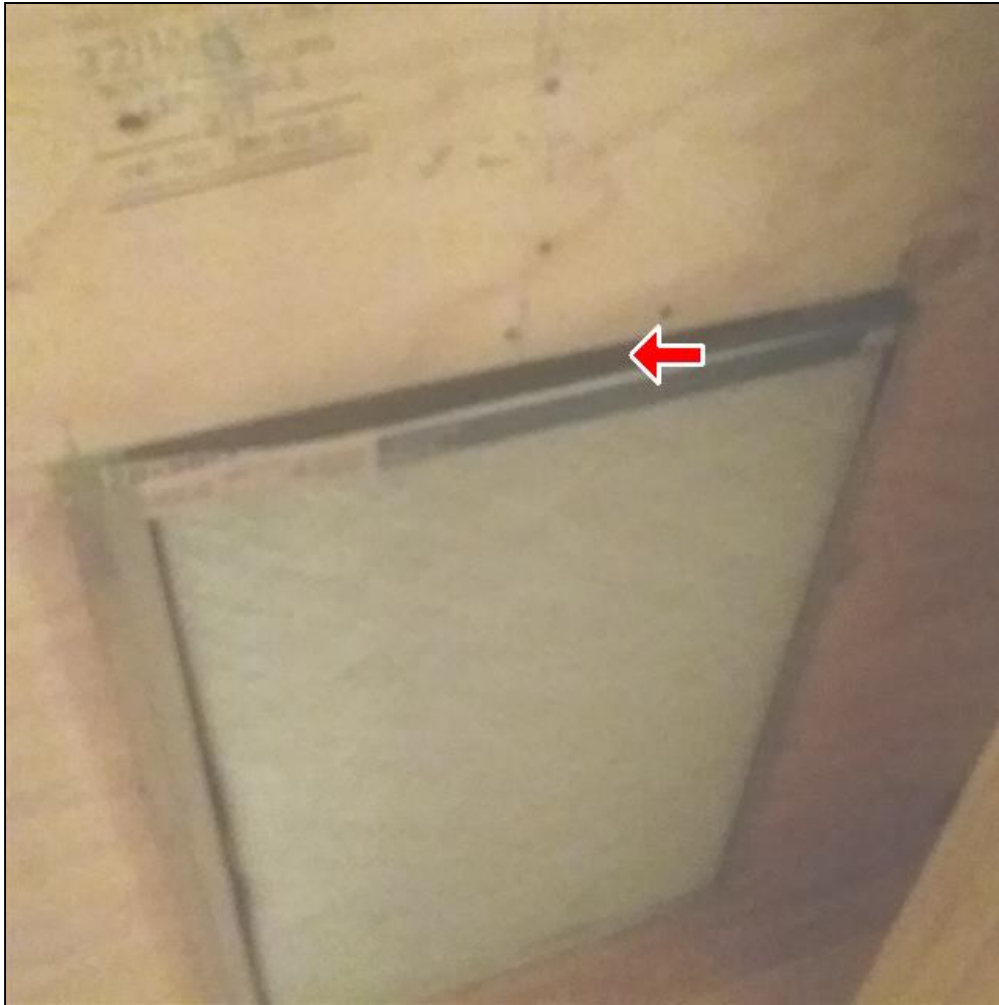
Air is bypassing the filter at top on the HVAC system for left side of home. Filter needs a retainer to keep flat to wood box.

8.3 Item 1(Picture) Air is bypassing the filter at top on the HVAC system for left side of home. Filter needs a retainer to keep flat to wood box.

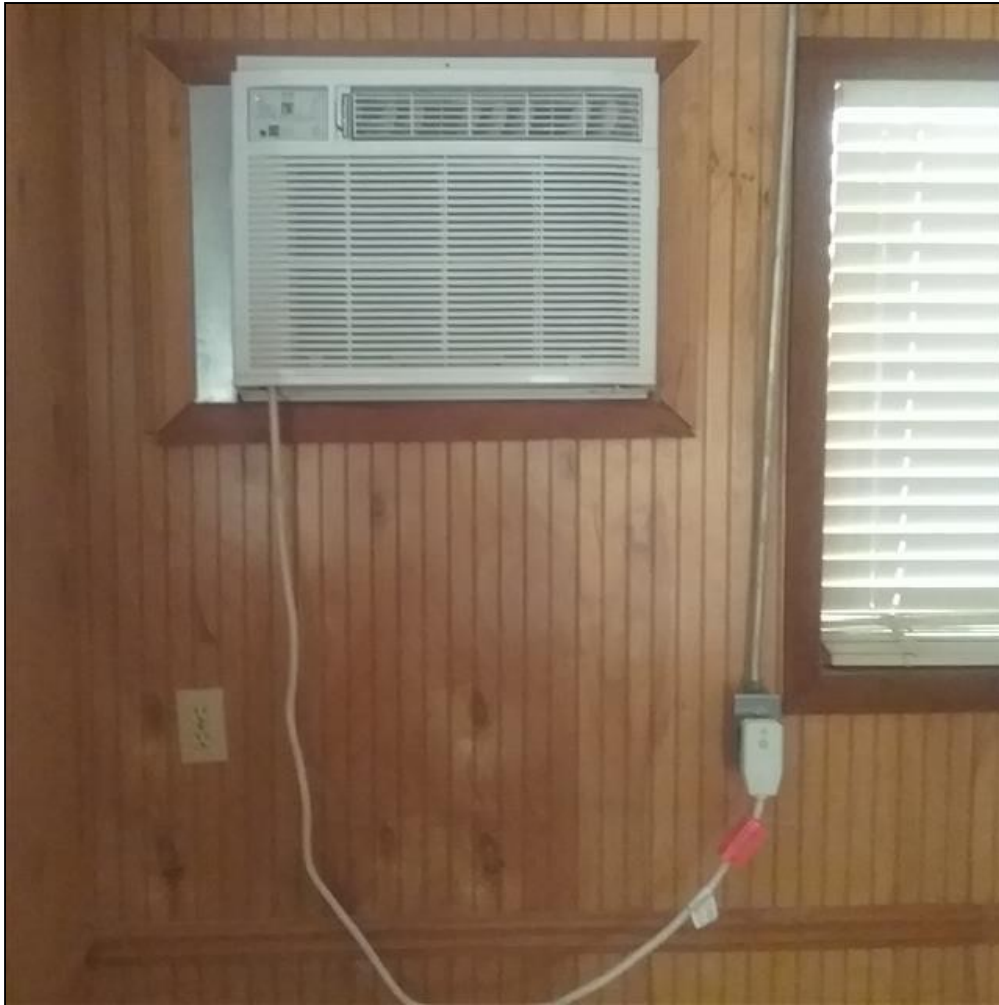
(1) Window AC unit in front of cottage not functioning when tested.

8.8 Item 1(Picture) Window AC unit in front of cottage not functioning when tested.

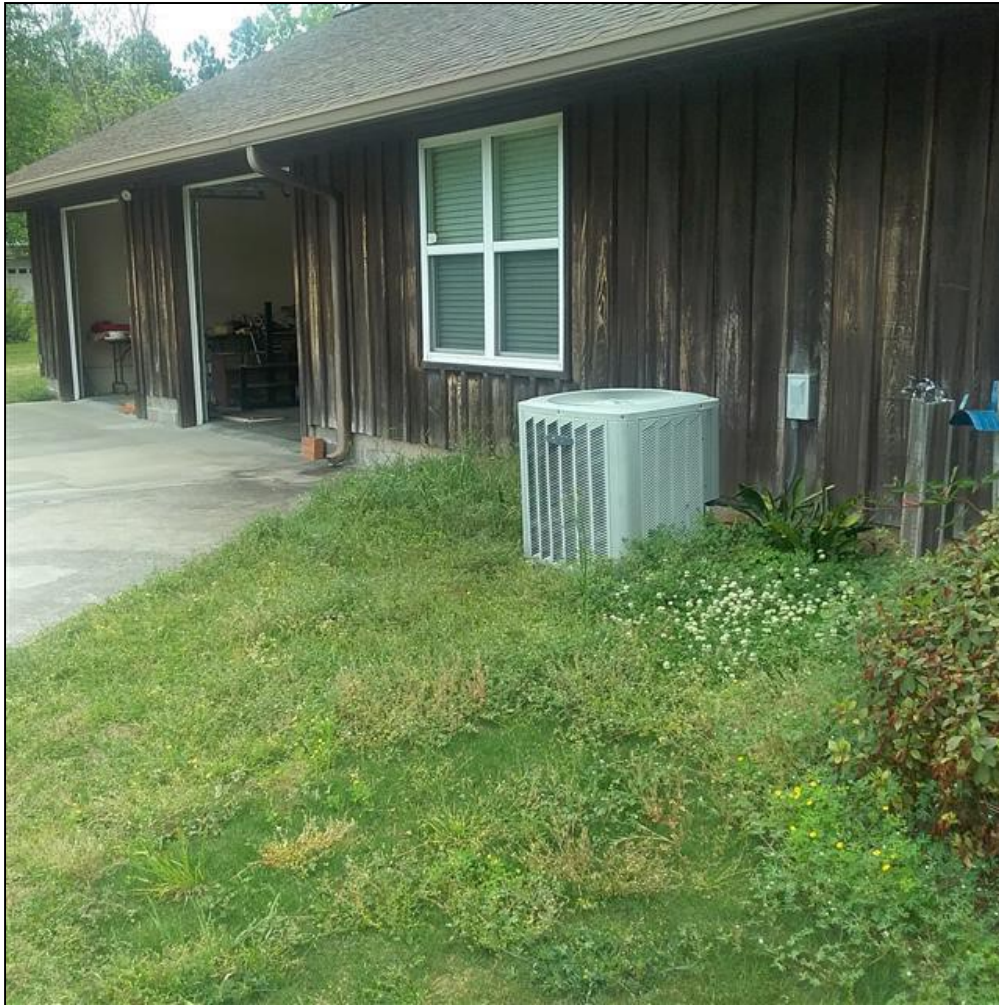
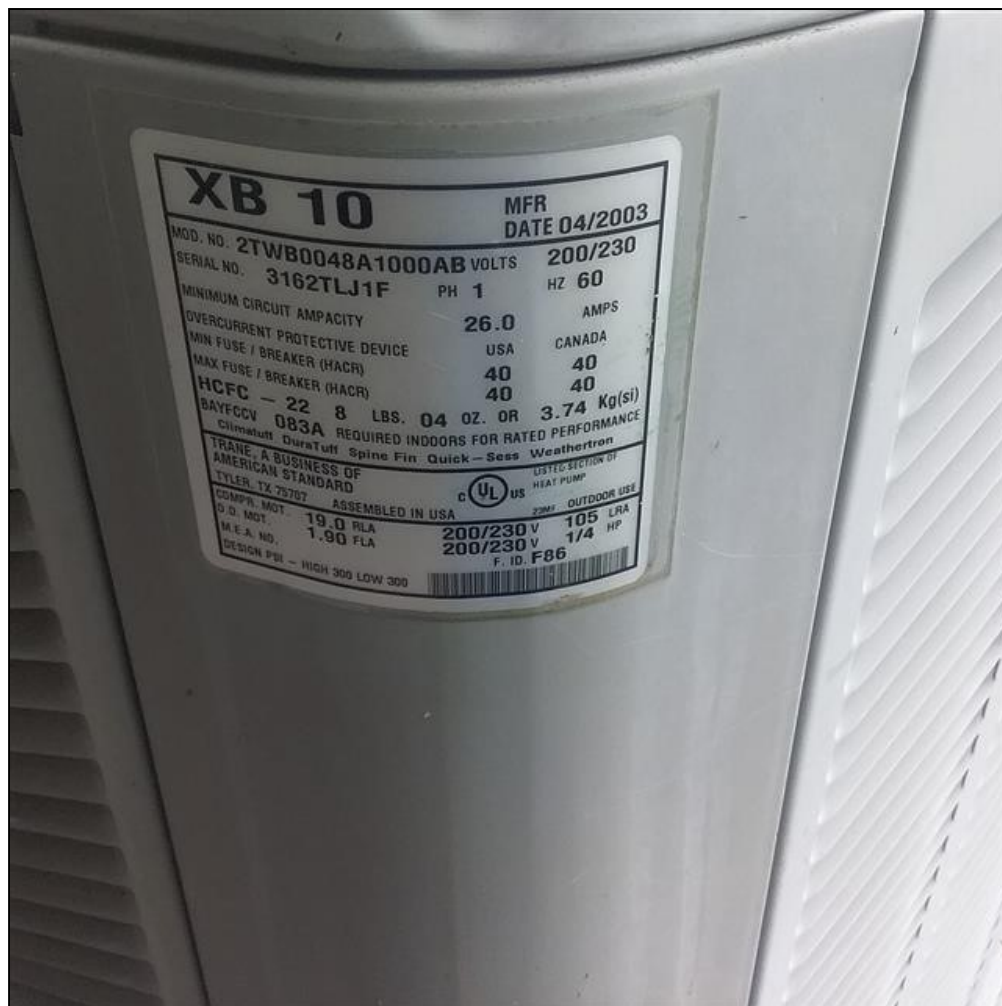
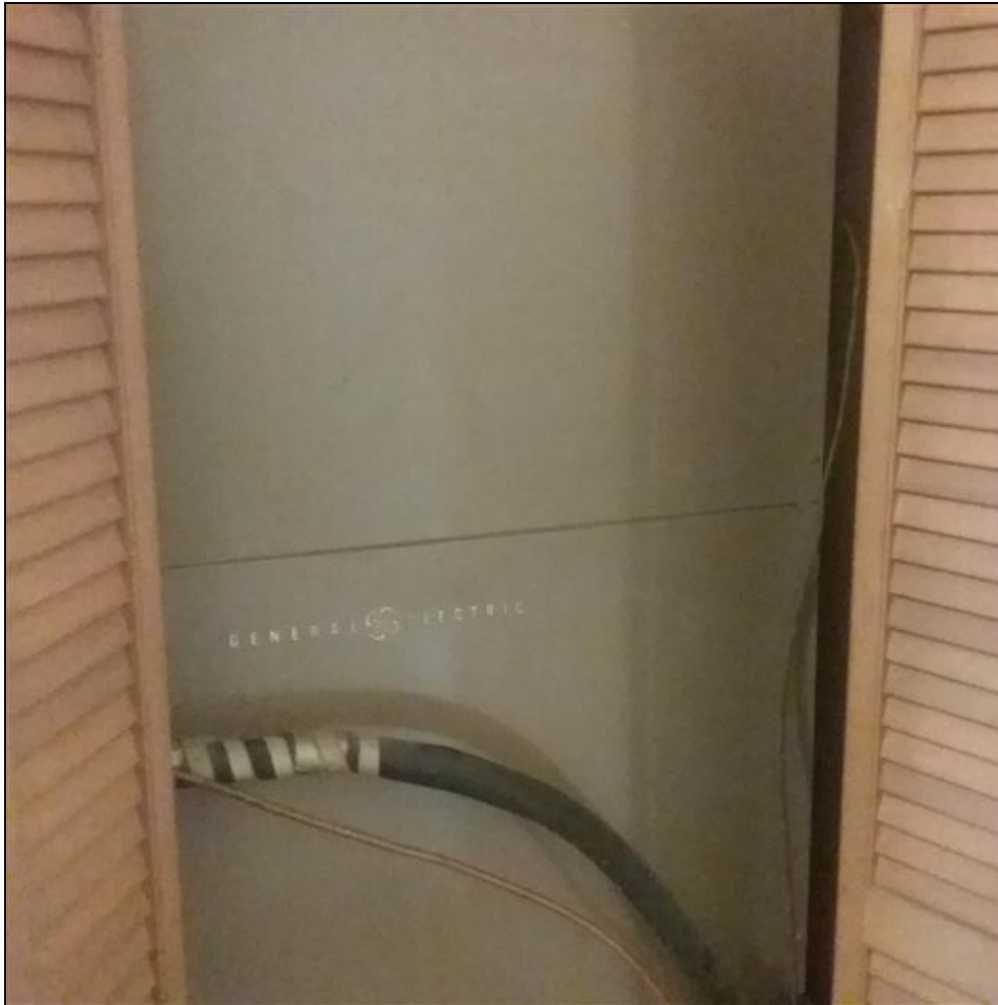
(2) The HVAC system serving the middle portion of home is at end of its expected service life, and will need to be replaced in the near future.

8.8 Item 2(Picture) The HVAC system serving the middle portion of home is at end of its expected service life, and will need to be replaced in the near future.

8.8 Item 3(Picture) The HVAC system serving the middle portion of home is at end of its expected service life, and will need to be replaced in the near future.

8.8 Item 4(Picture) The HVAC system serving the middle portion of home is at end of its expected service life, and will need to be replaced in the near future.

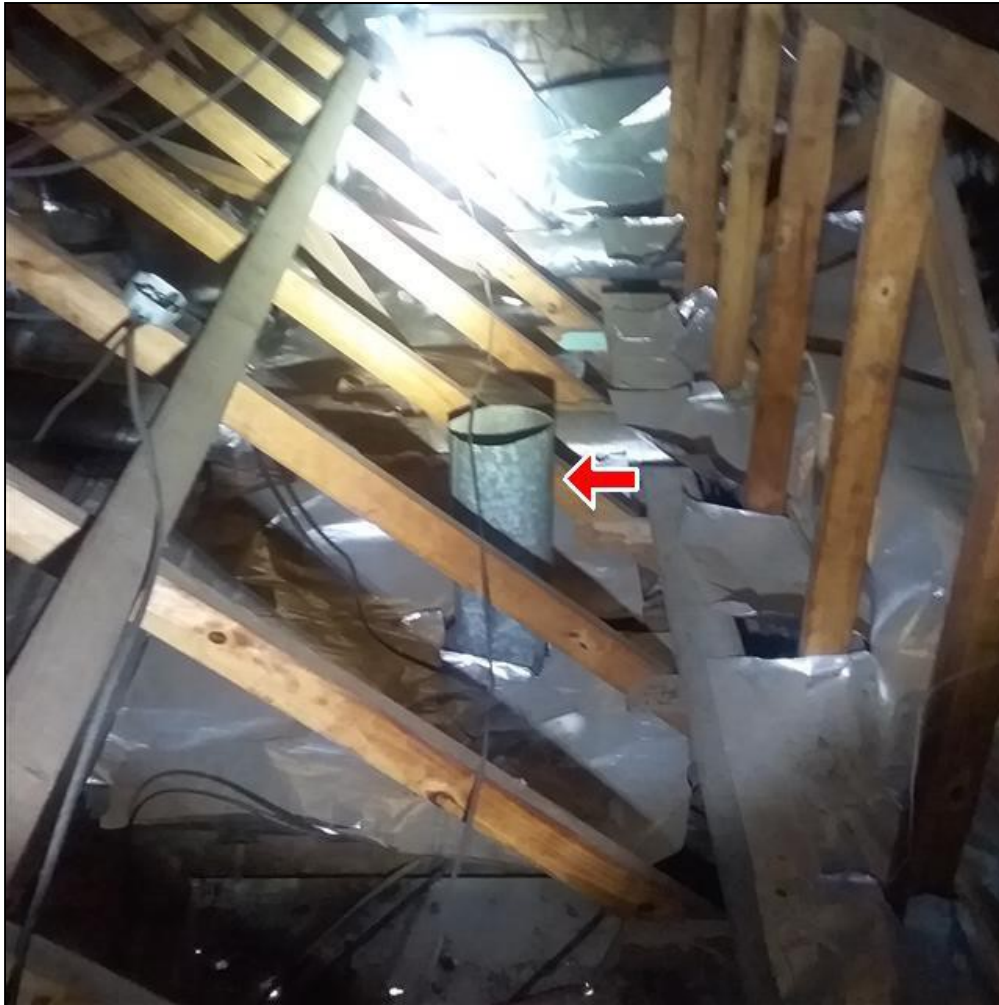
(1) Kitchen exhaust Hood pipe needs to be vented through roof to exterior.

9.4 Item 1(Picture) Kitchen exhaust Hood pipe needs to be vented through roof to exterior.

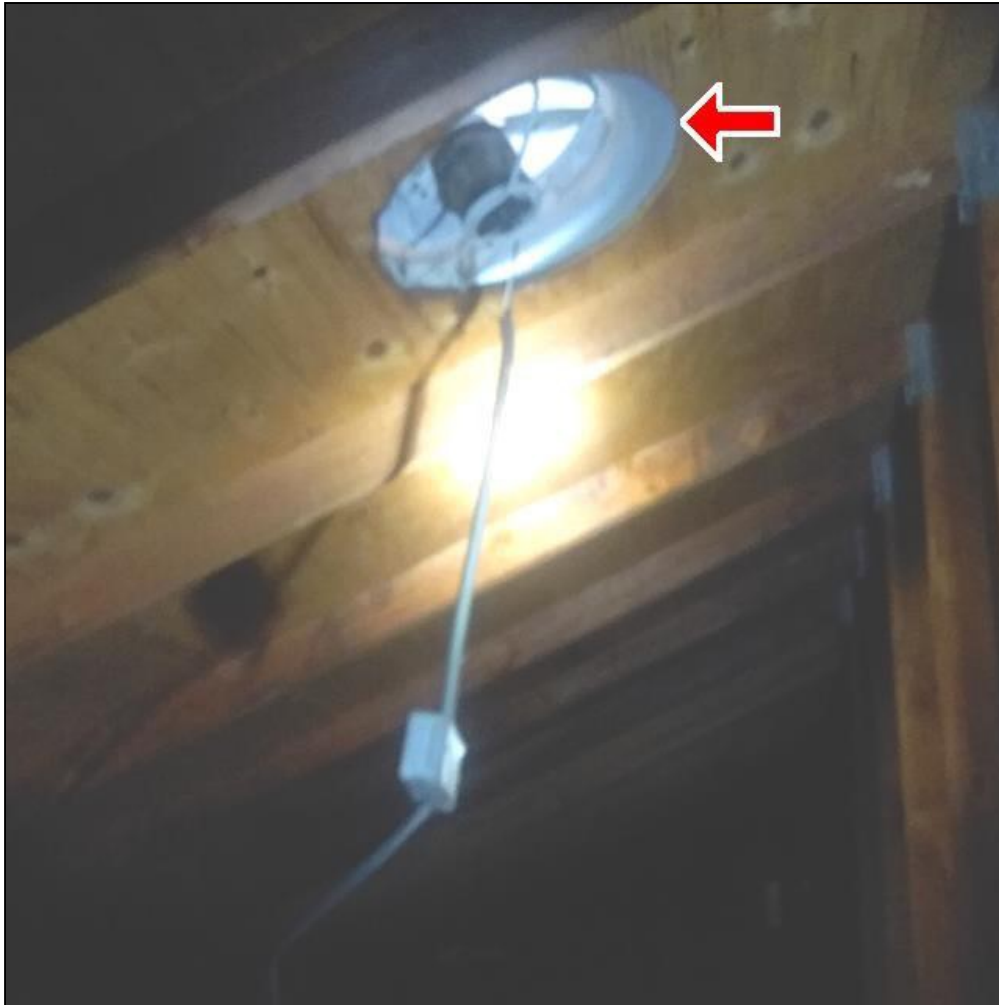
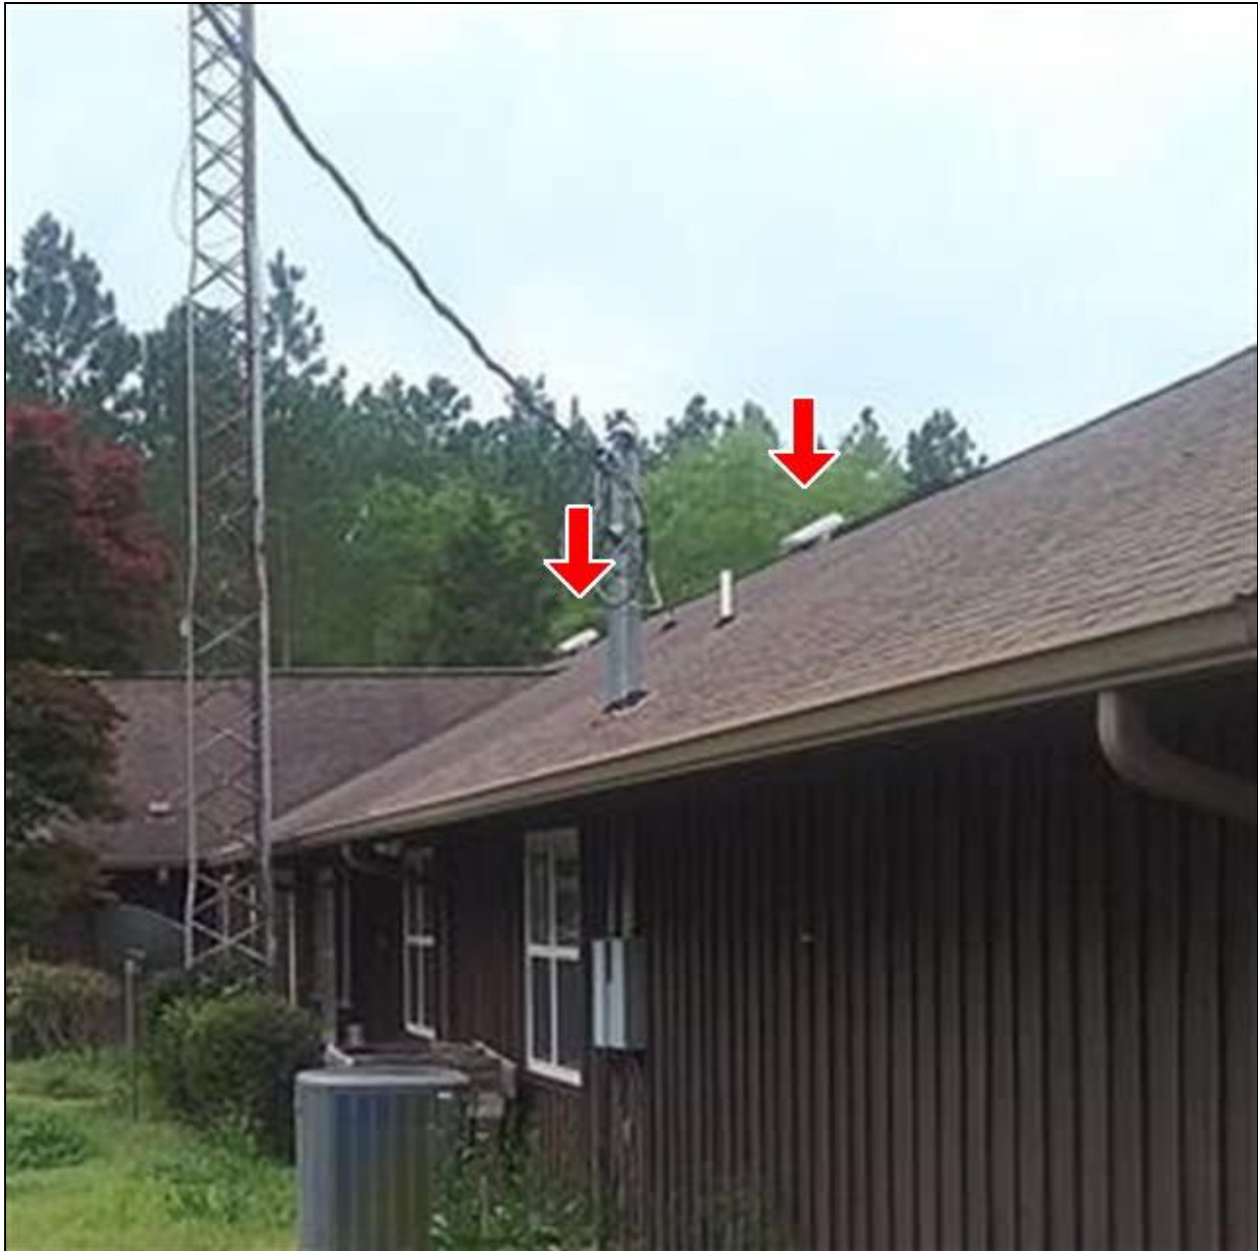
Both roof attic power ventilator motors are bad, and need to be replaced.

9.5 Item 1(Picture) Both roof attic power ventilator motors are bad, and need to be replaced.

9.5 Item 2(Picture) Both roof attic power ventilator motors are bad, and need to be replaced.

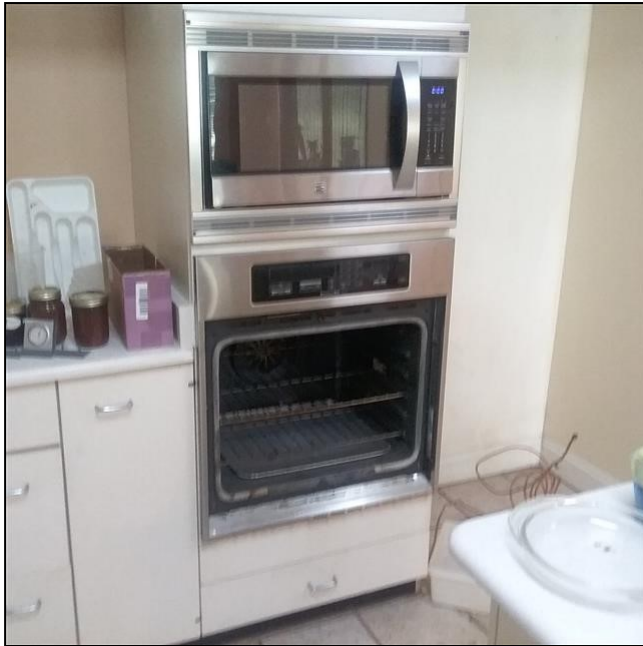
10.1 Item 1(Picture)

Oven door needs to be replaced.
